N.C. Stream Assessment Method (NC SAM)

User Manual

Prepared by the N.C. Stream Functional Assessment Team

Version 2.1
August 2015

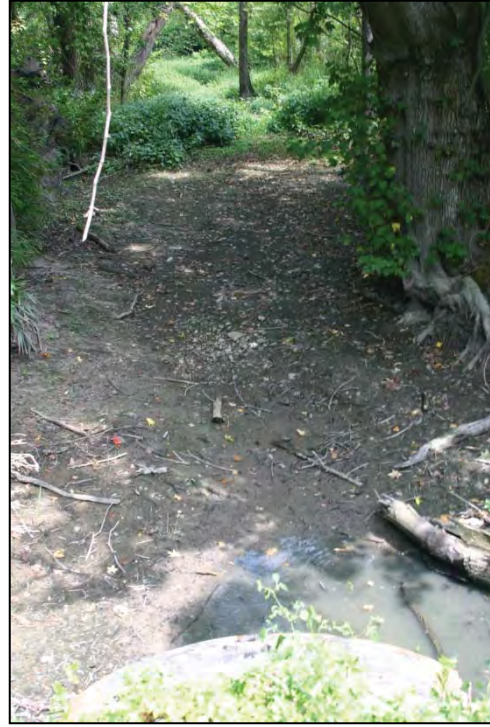
These photos provide evidence of some of the effects of culverts on streams. Photo 2-1 shows a plunge pool below a perched culvert draining an urban area on an unnamed tributary to Swift Creek (Pa1) in Wake County. Photo 2-2 shows a human-straightened stream reach downstream of a culvert on an unnamed tributary to the Pasquotank River (Oa2) in Camden County. Photo 2-3 shows an organic debris dam at the upstream end of a culvert on an unnamed tributary to Catawba Creek (Pb1) in Gaston County. Photo 2-4 shows channel destabilization resulting from perched pipes on Church Creek (Pa3) in Rowan County.

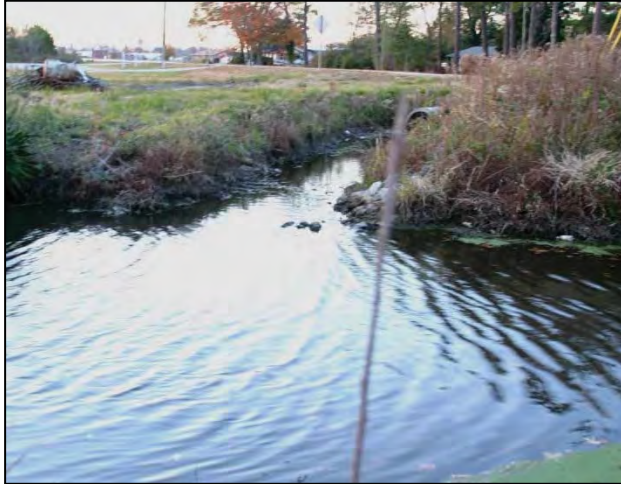
Photo 2-5 shows a streamside area ditch draining to an unnamed tributary to the Scuppernong River (Ia3) in Tyrrell County. The removal of streamside trees, saplings, and shrubs has resulted in an acceleration of streamside area drainage and stream shading being largely absent. Photo 2-6 shows a streamside area ditch draining to Back Creek (Pa4) in Mecklenburg County.

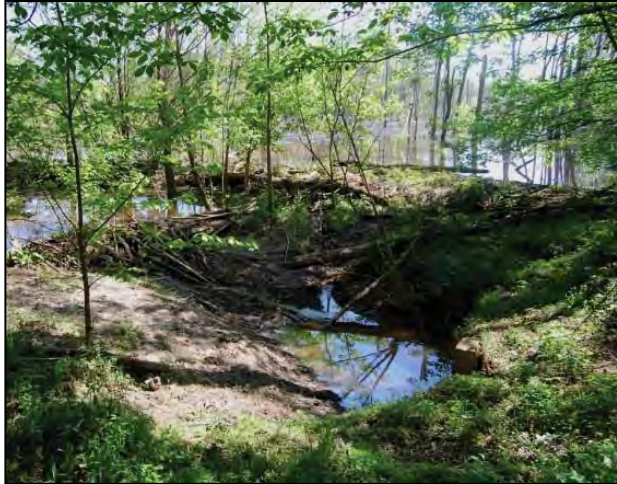
Both Photo 2-7 (unnamed tributary to Jimmy's Creek [Pa1] in Davidson County) and Photo 2-8 (Hominy Creek [Pa4] in Wake County) are beaver-impounded streams. The reach of stream above each dam has been converted by the presence of the dam from a lotic to a lentic system. Each of these dams acts as an "obstruction that passes some flow during low-flow periods," so each dam is considered a baseflow contributor to the downstream reach. Photo 2-9 shows a hardwood tree with beaver damage in the streamside area of an unnamed tributary to Knapp of Reeds Creek (Pa3) in Granville County. Photo 2-10 shows the streamside area of Cattail Creek (Pa4) in Johnston County shortly after a beaver dam has been removed.

Beaver activity may have a substantial effect on all Class 1 stream functions, to the point of elimination, resulting in the conversion of the stream (a lotic system) into an open water area (a lentic system) or vegetated wetlands (Photo 2-7 and Photo 2-8). Whether the effects are considered negative or positive depends on the circumstances. Negative effects may include altered baseflow, increased floodplain access frequency and duration, reduced wooded riparian buffer, altered sediment transport, reduced thermoregulation, decreased dissolved oxygen, and an alteration in available in-stream and streamside habitats. Photo 2-9 shows beaver damage to streamside area hardwood trees. Photo 2-10 shows a streamside area barren of wooded vegetation. This site formerly supported a beaver impoundment, and the dam has been removed recently. A positive effect of beaver activity is that dams may act as baseflow contributors since they typically pass flow to receiving streams during low-flow periods.

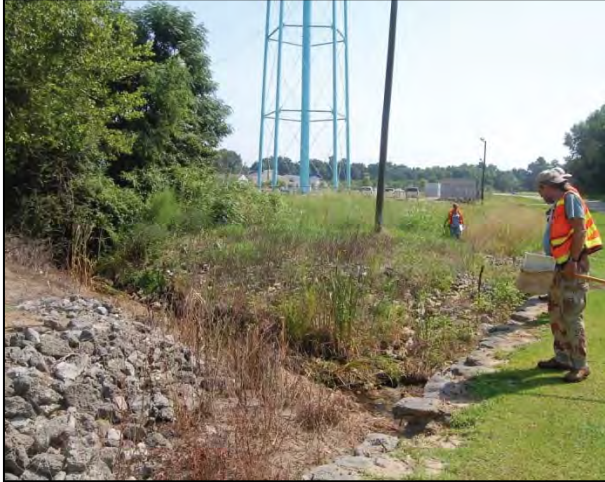
These photos provide examples of the effects of maintained utility corridors. Photo 2-11 (Turkey Creek [Ia4] in New Hanover County) and Photo 2-12 (South Prong of Little River [Pb3] in Montgomery County) show perpendicular stream crossings by utility line corridors that are subject to regular vegetation maintenance. Note the use of rip-rap to stabilize banks in the former photo. Photo 2-13 (Black Creek [Pa3] in Wake County) shows a maintained utility line corridor situated parallel to a reach of stream. The removal of vegetation has resulted in degraded shading of the reach shown. Photo 2-14 (Back Creek [Pa3] in Mecklenburg County) shows a maintained sewer line corridor with a diagonal crossing of a stream. The inset is an aerial photograph of the same site.

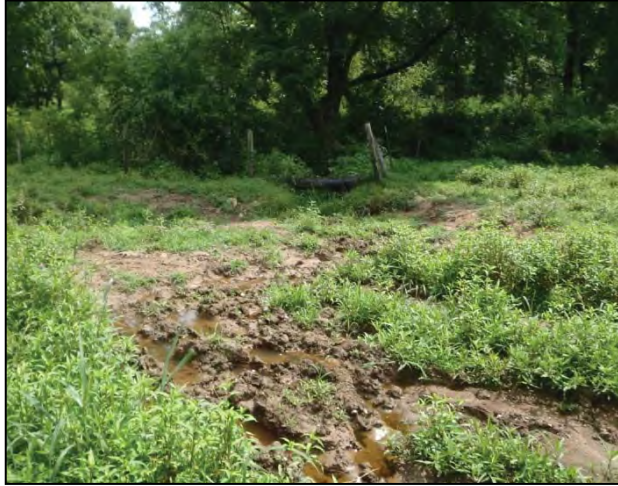
Photo 2-15 shows the near obliteration by cattle shear of an unnamed tributary to Newfound Creek (Pa1) in Alamance County. Photo 2-16 shows an active goat pasture abutting Belch Branch (1a2) in Lenoir County. The streambed is regularly disturbed by goat hooves, and the herb and shrub vegetation in the wooded buffer have been removed by grazing. Photo 2-17 shows streamside area vegetation alteration, bank shear, turbidity, and point source pollution resulting from cattle access to Middle Prong Hammer Creek (Pa3) in Montgomery County. This photo provides a good example of how stream shading has been degraded. Photo 2-18 shows livestock excrement being discharged directly into South Muddy Creek (Pa3) in McDowell County.

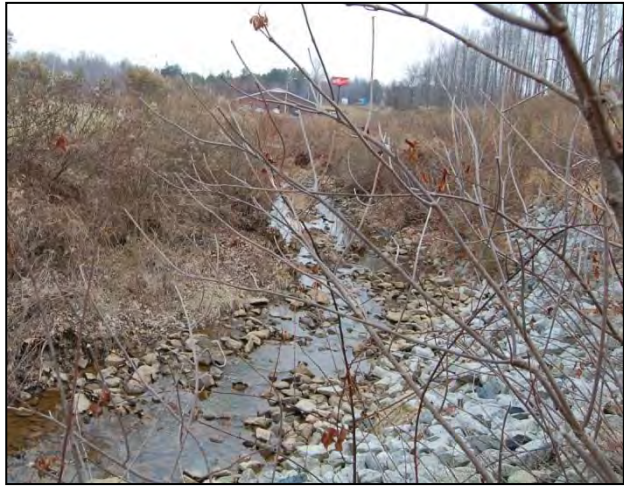
Photo 2-19 and Photo 2-20 are streams hardened with standard-sized rip-rap on an unnamed tributary to Little River (Pa3) in Montgomery County and an unnamed tributary to Lockwood Folly River (Oa2) in Brunswick County, respectively. Photo 2-21 shows hardening by concrete of the bed and banks of Skewakee Gut (Ia3) in Martin County, and Photo 2-22 shows hardening by stone blocks of the bed and banks of an unnamed tributary to Grant's Creek (Pa2) in Salisbury's City Park, Rowan County. Stream shading is degraded in Photo 2-19 and Photo 2-22. Stream shading is gone or largely absent in Photo 2-20 and Photo 2-21, due in part to maintained turf abutting these streams in a residential area and a community park, respectively.

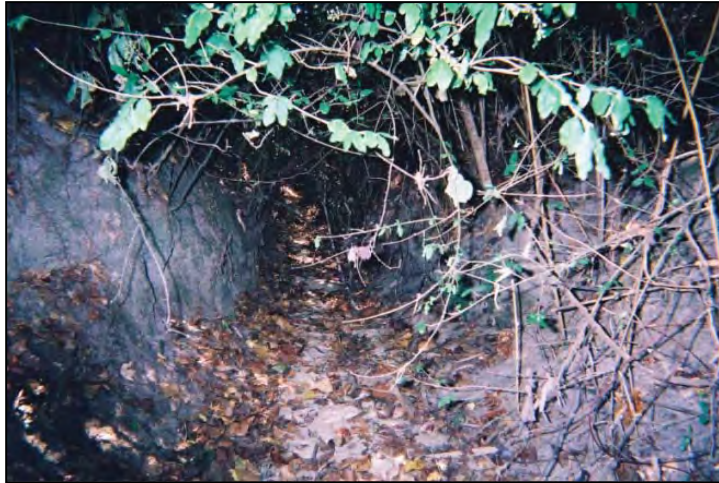
Photo 2-23 shows a straightened and deepened unnamed tributary to Beaverdam Swamp (Ia2) in Sampson County under a dense thicket of Chinese privet. This dense thicket has formed following removal of the tree and sapling strata, resulting in degraded shading for the reach shown. Photo 2-24 is an unnamed tributary to South Fork Catawba River (Pb1) in Gaston County that is situated in an area dominated by kudzu.

Non-native invasive plants can degrade the Class 1 function Habitat mainly through their effect on streamside vegetation composition and structure. For instance, many non-native invasives such as Chinese privet (*Ligustrum sinense* (Photo 2-23) and kudzu (*Pueraria lobata*) (Photo 2-24) can create semi-monocultures to the detriment of native plants, thereby drastically reducing streamside area diversity. Additionally, many of these species also affect stream function by altering the structure of the riparian buffer. Kudzu, for example, can overwhelm and kill a forest canopy resulting in increases in water temperature due to more sunlight, increased turbidity due to the loss of bank-stabilizing vegetation, and loss of woody inputs into the stream system.

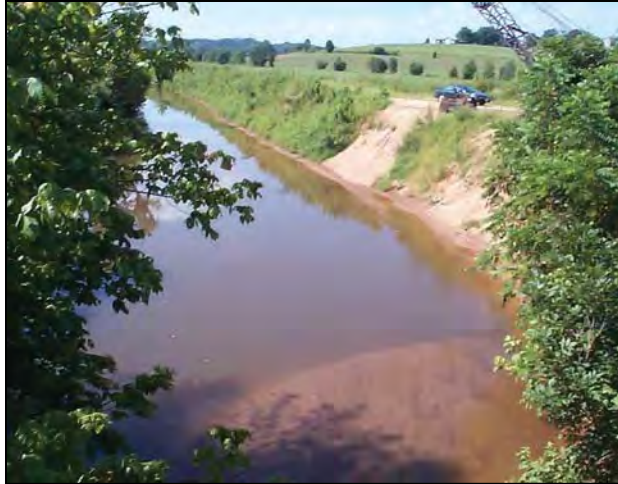
Photo 2-25 shows a sand-dipping operation on Clark Creek (Pa4) in Catawba County (photo courtesy of Tom Yocum). Note the tongue of sand filling the sand dipper area. Photo 2-26 shows a gravel-mining operation on Little Buck Creek (Ma4) in McDowell County.

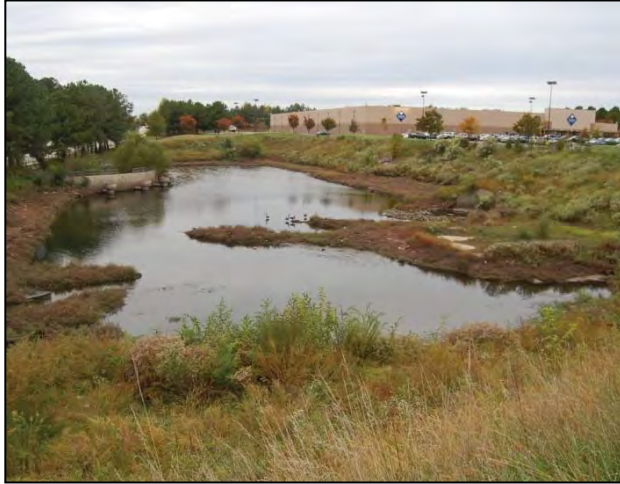
These photos show stormwater Best Management Practices (BMPs) that treat initial runoff following precipitation events. Photo 2-27 shows a wet detention pond treating stormwater from a suburban shopping center in Wake County. This type of feature provides baseflow to the receiving tributary through slow runoff following precipitation events and groundwater infiltration thereafter. Photo 2-28 shows a rain garden in the parking lot of the Raleigh Wetland Center in Wake County. Photo 2-29 shows porous pavement in the parking lot of the N.C. Botanical Garden in Chapel Hill, Orange County. Photo 2-30 shows a grassed swale in a topographic crenulation between agricultural fields in Union County.

Many new projects in urban areas are now required to install stormwater Best Management Practices (BMPs) such as wet detention ponds (Photo 2-27), bioretention (rain gardens) (Photo 2-28), and porous pavements (Photo 2-29). These BMPs may not be obvious to the assessor since they are often located behind commercial areas and are often fenced off from public access due to safety concerns. In addition, agricultural BMPs such as grassed swales (Photo 2-30), contour farming (Photo 2-31), and no-till agriculture (Photo 2-32) are common in the rural landscape and can significantly reduce pollutant input into local streams. These BMPs are usually readily observable in the agricultural landscape. Finally, silvicultural BMPs such as flashboard risers are often installed in the ditch network draining intensive forestry operations with significant benefits with respect to modifying the draining of surface and ground water to nearby streams. These silvicultural BMPs may be harder to observe in the landscape since they are often located in densely wooded areas; however, the aluminum riser may be visible in some instances. All of these BMPs can serve to reduce the effect of stormwater discharges on streams, but since these urban BMPs are usually only present in fairly new developments, and the other types of BMPs are not often required (although they are encouraged), older developed landscapes usually do not have BMPs to ameliorate the impact of stormwater discharges. The assessor is encouraged to pay close attention to the presence of stormwater discharges and any associated BMPs while traveling to the site and during the site evaluation process.

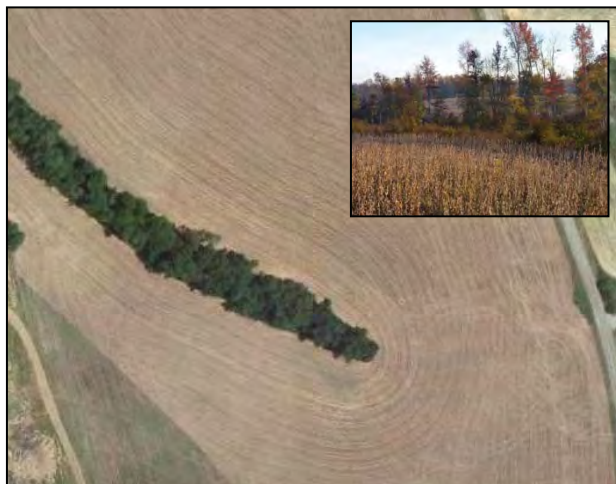
Photo 2-31 shows an agricultural field subject to contour farming in Randolph County. The wooded vegetation is growing along an unnamed tributary to Bob Branch (Pb1). In this example, active row crops occur within 30 feet of, but not abutting the stream. Photo 2-32 shows an agricultural field subject to no-till farming. The field on both sides of this unnamed tributary to Stonyton Creek (Ia1) in Lenoir County contains the roots and lower stalks of a corn crop from the previous year.

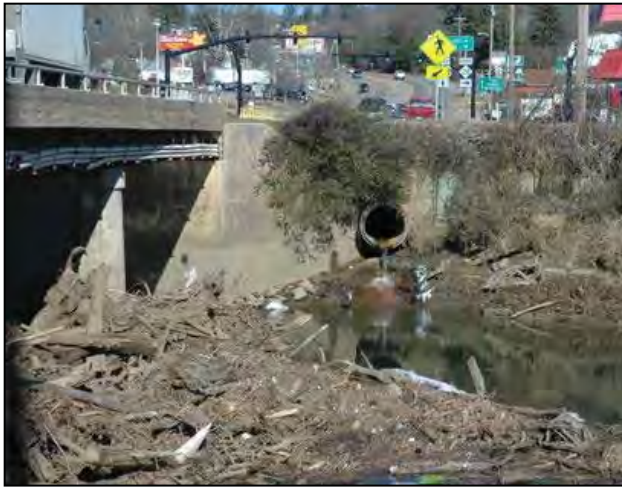
Photo 2-33 shows the Little Tennessee River (Ma4) passing through Franklin in Macon County. Flashy flows from the high percentage of impervious surfaces are likely contributors to the concentration of woody debris at the bridge crossing. Photo 2-34 shows Town Creek (Pa4) passing through Salisbury in Rowan County. Runoff from the adjacent commercial development can move rapidly through the sparse buffer into this stream. In some cases, areas of compacted soils (such as those often found in pastures) can act as impervious or partially impervious surfaces by reducing infiltration and increasing rates of runoff. From the scientific literature, it is clear that increased levels of impervious surfaces are associated with degraded aquatic ecosystems, and many studies of aquatic insect communities have found that degradation starts at a level between 8 to 12 percent impervious surfaces in a particular watershed (Stepenuck et al. 2002). However, the NCDWR stormwater rules generally have a trigger of 24 percent impervious surface, 12 percent in watersheds characterized by more sensitive waters. Therefore, 24 and 12 percent are the thresholds used in NC SAM for Metric 17 (Baseflow Detractors, p. 112) in order to maintain regulatory consistency.

These photos show streamside areas with a high percentage of impervious surfaces. Photo 2-33 is the Little Tennessee River (Ma4) in Franklin, Macon County and Photo 2-34 is Town Creek (Pa4) in Salisbury, Rowan County. Such impervious surfaces decrease the streamside area's ability to contribute to baseflow by preventing infiltration of water into the soil and subsequent groundwater flow to the stream. The degradation of streamside area vegetation has resulted in shading being gone or largely absent in the reach shown.

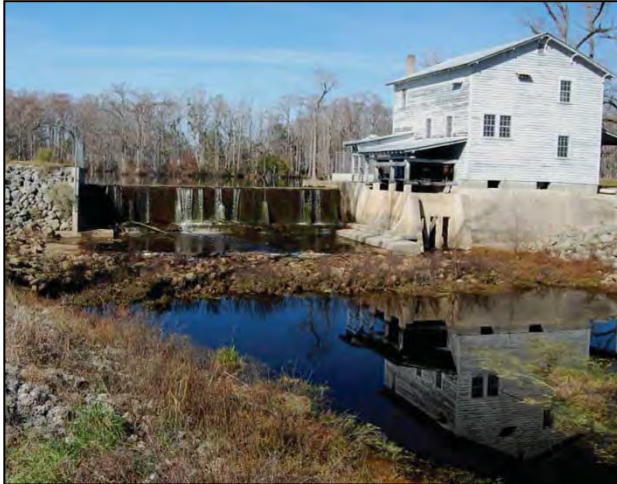
Photo 2-35 shows a dam and millhouse on Brock Millpond, an impoundment on Crooked Run (Ia4) in Jones County. Photo 2-36 shows a low dam on Flat Creek (Ma4) in Black Mountain, Buncombe County.

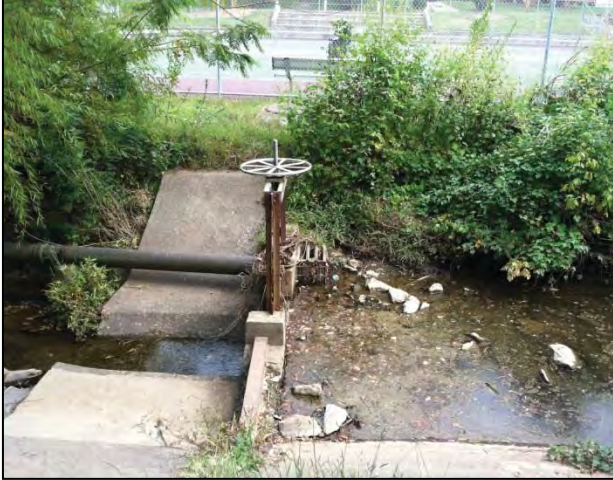
Photo 2-37 shows a weir and water transfer pipe on an unnamed tributary to Grant's Creek (Pa2) in Rowan County. This pipe is used to move water from the stream to an "off-line" pond within a public park.

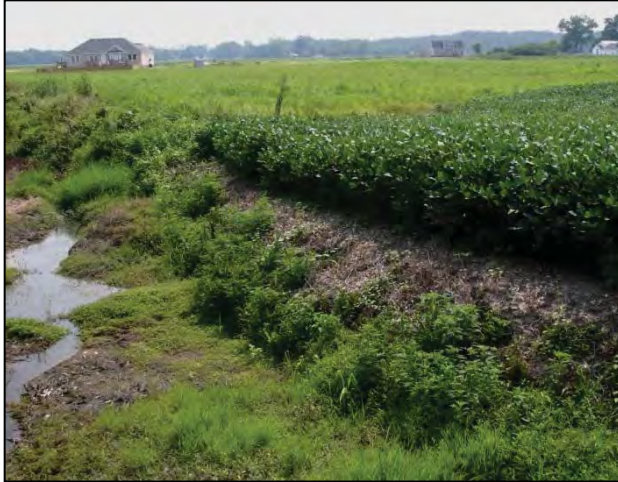
Photo 2-38

Active row crops and maintained turf (Photo 2-38 and Photo 2-39, respectively) can act as significant stressors to aquatic ecosystems through degradation of all three Class 1 functions. These practices may result in unstable banks, which reduce water quality through excessive sediment inputs. These practices may also alter the normal wooded streamside area and thereby remove significant benefits of a wooded buffer abutting the stream (Baseflow, Streamside Area Attenuation, Stream Stability, Upland Pollutant Filtration, Thermoregulation, In-stream Habitat, and Streamside Habitat). These practices are also expected to be a source of pollutants such as sediment, nutrients, and pesticides. If these land uses are set back from the channel with a wooded buffer that can effectively treat this runoff, then these land uses will have a dramatically reduced impact on stream health. For instance, a 50-foot wide wooded buffer has been found to remove 62 percent of the total nitrogen entering the stream (Mayer et al. 2007). Mayer et al. (2007) also found a non-linear relationship of buffer width to nitrogen removal efficiency where wider buffers removed more nitrogen but at a reduced rate. NC SAM uses the width of wooded buffers adjacent to stream (Metric 19: Buffer Width and Metric 21: Buffer Stressors [see p. 119 and p. 129, respectively, and the Field Assessment Form]) as indications of the impact these land uses have on water quality and habitat.

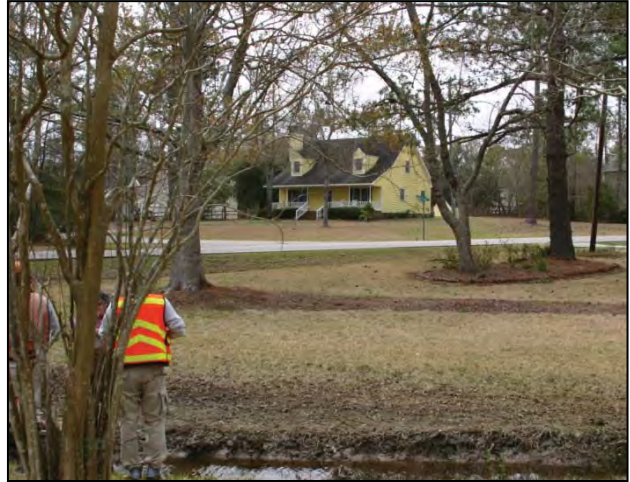
Photo 2-38 shows agricultural land extending to the top of a man-made extension of Joyce Creek (Oa3) into an interstream divide in Camden County. The removal of woody vegetation from the streamside area results in stream shading being largely absent from the reach in view. Photo 2-39 shows a maintained lawn with low wooded stem density abutting the bank of an unnamed tributary to Pages Creek (Oa2) in New Hanover County.

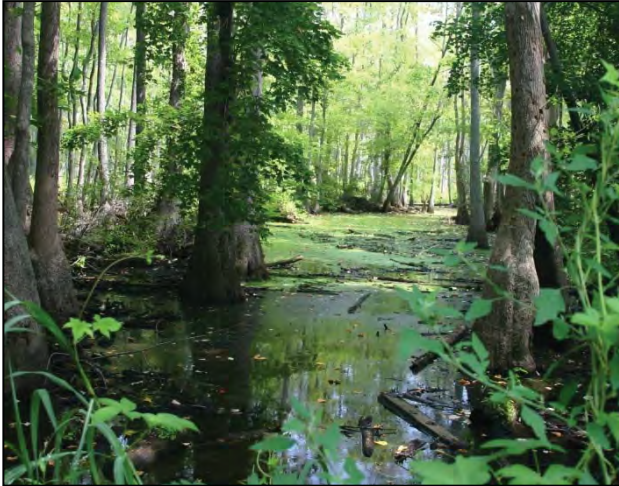
These four photographs show streams characterized by “a” valley shapes. Photo 3-1 is an unnamed tributary to the Perquimans River (Oa2) in Perquimans County; this reach flows through a mature forest characterized by medium to high stem density. Photo 3-2 is an unnamed tributary to the Neuse River (Ia2) in Johnston County; the aquatic habitat within this reach is enhanced by the presence of multiple logs. Photo 3-3 is the confluence of two unnamed tributaries to Crabtree Creek in Wake County; these are Pa2 streams both above and below the confluence. Photo 3-4 shows Elk Creek (Ma3) on the Watauga/Ashe County line.

Visual examples of “mature forest” are provided by Photo 3-1, Photo 4-30, Photo 4-115, and Photo 4-121.

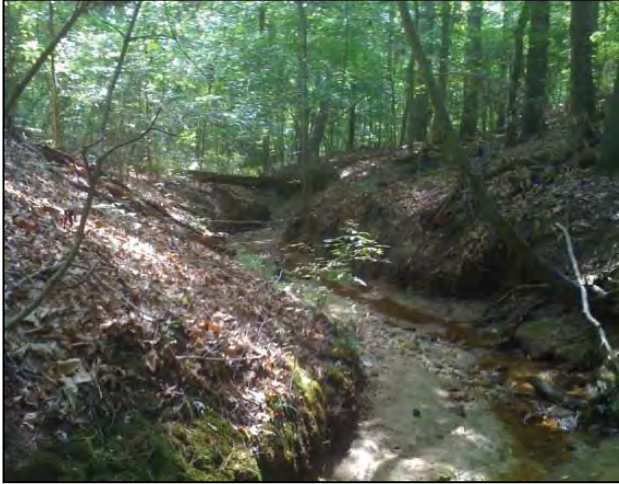
These photos show streams characterized by “b” valley shapes. Photo 3-5 is an unnamed tributary to the Cape Fear River (Ib2) in Cumberland County, and Photo 3-6 is an unnamed tributary to the Neuse River (Ib1) in Craven County. Both of these streams are cutting through high bluffs on the right banks of the large rivers. Photo 3-7 shows an unnamed tributary to Rogers Lake (Pb2) in Granville County, a stream that drains a series of agricultural fields. Photo 3-8 shows two unnamed tributaries to Elk Creek and their confluence within a residential development (characterized by low stem density) in Ashe County. These reaches, both above and below the confluence, are Mb1 streams.

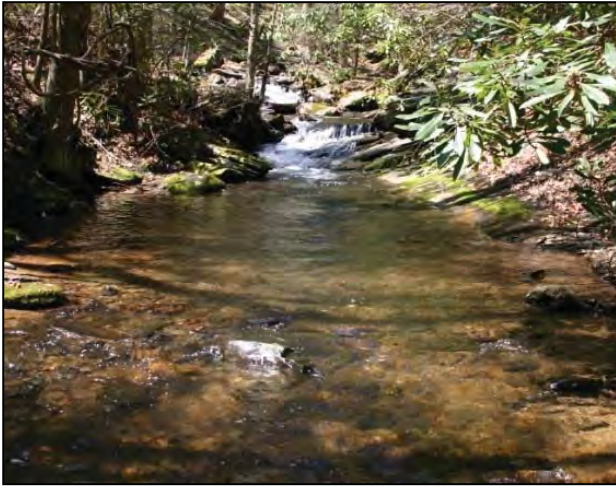
These photos show streams characterized by “b” valley shapes. Photo 3-9 shows an unnamed tributary to Three Top Creek (Mb3) in Ashe County. Photo 3-10 shows Cold Springs Creek (Mb4) in Haywood County.

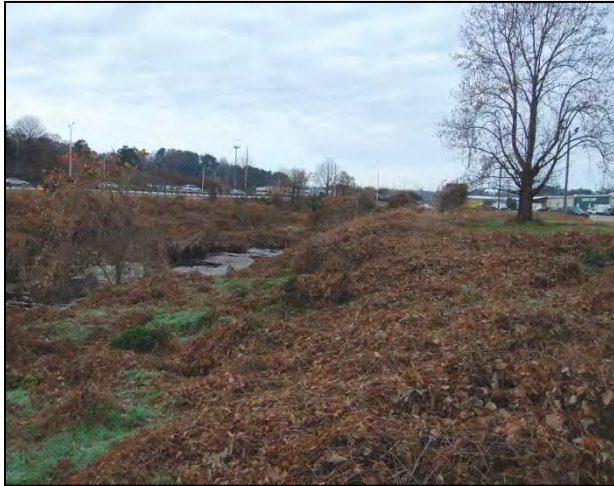
Photo 3-11 shows a view upstream (to the southwest) on Pigeon House Creek (Pa3) in Raleigh. This stream is bounded on the right bank by Capital Boulevard, a six-lane, divided highway, and on the left bank by a two-lane paved road and industrial warehouses. Superficially, this stream appears to be in a “b” valley shape, but a look at the topographic mapping (Photo 3-12, the star denotes the approximate location of the camera and the arrow is the direction of view in Photo 3-11) assists with the determination that this stream is incised and located in an “a” valley type characterized by heavy ground-surface manipulation of the floodplain terrace. The two lower photos are of tributaries that have been excavated in interstream divides. Photo 3-13 shows an unnamed tributary to the Pamlico Sound (Oa3) in Hyde County. The removal of woody vegetation from the streamside area has resulted in shading being largely absent from the reach shown. Photo 3-14 shows an unnamed tributary to the Albemarle Sound (Oa2) in Tyrrell County.

- If the assessor cannot tell what type of valley existed prior to disturbance, topographic and/or soils mapping may prove useful in determining pre-disturbance valley shape (Photo 3-11 and Photo 3-12). If the pre-disturbance valley shape still cannot be determined, a decision should be made based on predominant evidence of the current valley shape. In addition, a similar nearby reference stream of similar watershed size, soil type, and watershed shape can be examined to determine if it would be an appropriate comparison.

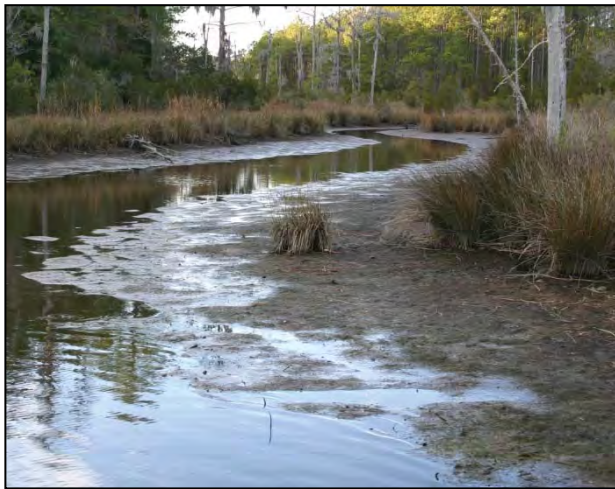
These photos are Tidal Marsh Streams influenced by wind tides and bounded by the NC WAM wetland type Salt/Brackish Marsh. Photo 3-15 shows an unnamed tributary to Goose Creek in Beaufort County. Photo 3-16 shows Whitehurst Creek in Beaufort County.

Tidal Marsh Streams are important conduits of organic export from tidal marshes to open waters as well as access corridors for aquatic life to intertidal zone habitats. As such, their level of connection to the streamside area is a crucial factor in their level of function. Photos 3-15 through 3-20 show examples of Tidal Marsh Streams.

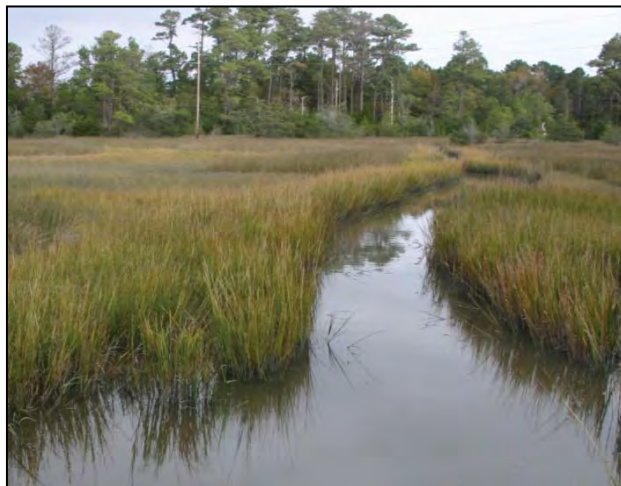
Photo 3-17 shows an unnamed tributary to Hidden Lake in Tyrrell County. This stream has been excavated in a wetland dominated by the NC WAM wetland type Tidal Freshwater Marsh, and the water level is primarily influenced by wind tides. Photo 3-18 shows Russell Creek in Carteret County, a stream bounded by NC WAM wetland type Salt/Brackish Marsh. The water level in this stream is primarily influenced by lunar tides. Photo 3-19 shows a downstream view of an unnamed tributary to Pages Creek immediately downstream of a road crossing (Bayshore Drive) in New Hanover county. The reach of stream above the road crossing is characterized by a small channel within a Salt/Brackish Marsh wetland, providing evidence that the reach in the near view was likely formerly bounded by marsh as well. This reach downstream of the crossing has been altered by both the construction of bulkheads and docks on the right bank and the dredging and widening of the channel to allow boat traffic. Although little to no marsh wetland is currently abutting the stream, fragmentary remnants of salt marsh persist along the left bank, providing evidence that this is a Tidal Marsh Stream. Photo 3-20 shows an unnamed tributary to Pages Creek immediately upstream of a road crossing (Bayshore Drive, in a different location than is shown to the left) in New Hanover County. This reach of stream is bounded to each side by a narrow band of Salt/Brackish Marsh, and the adjacent uplands are maintained as lawns.

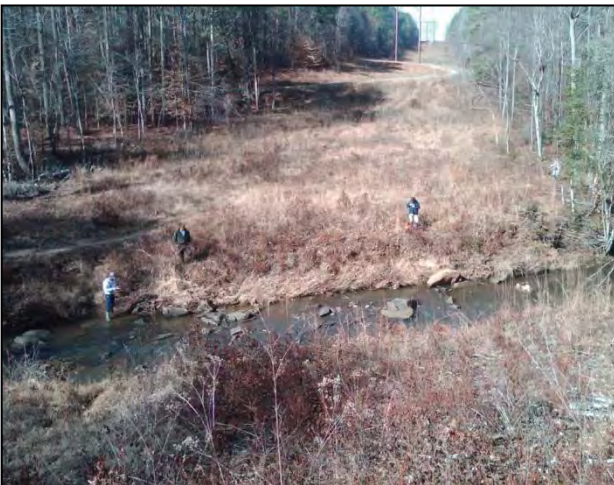
Photo 4-1

Larger scale or substantial changes in in-stream or streamside area conditions will result in a break in assessment reaches. For instance, a wide, maintained utility line corridor (Photo 4-1) will result in a break in assessment reaches.

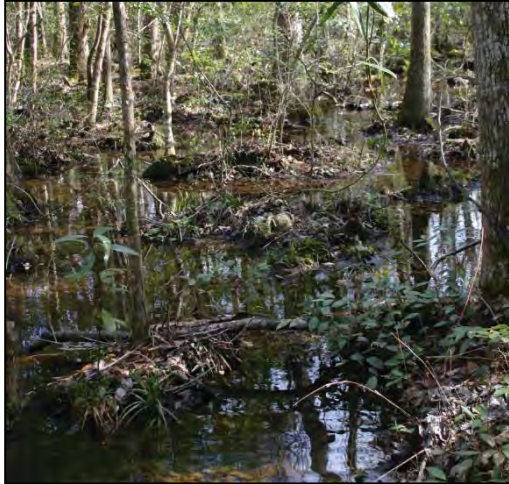
Photo 4-2 shows a multi-thread channel that is part of Honey Island Swamp (Oa3) in Brunswick County. This photo was taken in February. The channel is expected to have low-flow or be dry in the summer. Note in Figure 2 and Appendix E that while much of Brunswick County is in the Inner Coastal Plain NC SAM zone (I), the area mapped as Nonriverine Swamps and Peatlands level IV ecoregion is included within the Outer Coastal Plain NC SAM zone (O). Photo 4-3 shows an unnamed tributary to the Neuse River (Ia2) in Johnston County. This photo was taken in September, when the stream had no flow.

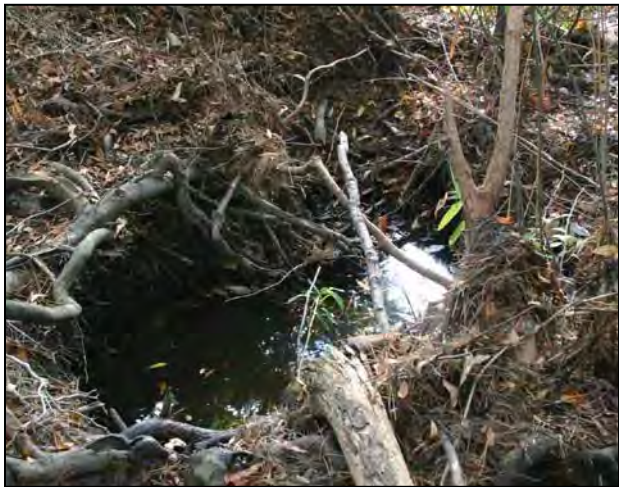
Photo 4-4 is an unnamed tributary to Carvers Creek (1a2) in Cumberland County. This stream drains a residential area characterized by maintained lawns and paved roads and driveways that increase surface runoff following precipitation events resulting in flashy flows in the stream. Channel water in the reach shown is characterized as “no flow, water in pools only.” Photo 4-5 is Hector Creek (1a3) on the Moore/Cumberland County line. This Sandhills stream is lacking channel water.

The assessor should consider the assessment reach when evaluating this metric. The “channel water” evaluation should be based on conditions that exist on the day of the site visit. A typical situation in which descriptor “B” (No flow, water in pools only) is appropriate is an assessment reach with water only in pool sections. If water only occurs in a scour hole, descriptor “C” (No water in assessment reach) is appropriate. Photo 4-4 provides an example of a stream that is evaluated as descriptor “B.” Photo 4-5 provides an example of a stream that is evaluated as descriptor “C.”

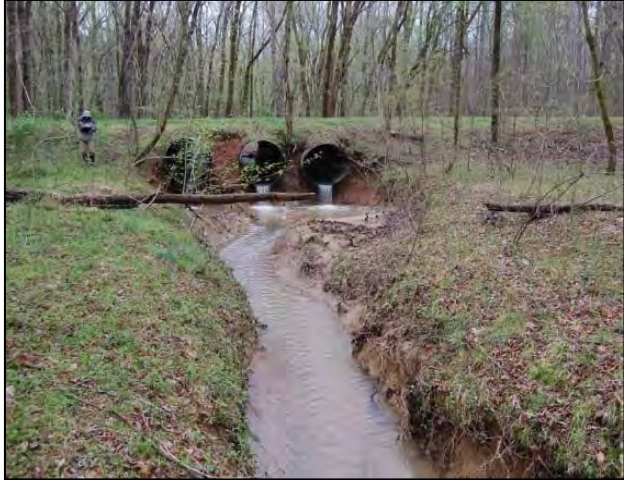
These photos provide examples of flow restrictions that have affected in-stream habitat. Photo 4-6 is Church Creek (Pa3) in Rowan County, a stream subject to flashy flows due to watershed disturbances. The restriction is caused by both a man-made berm across the floodplain and perched culverts, which have concentrated flow resulting in an unstable, down-cut channel. Photo 4-7 is an unnamed tributary to Jimmy's Creek (Pa1) in Davidson County and shows a reach of stream between a beaver dam and an undersized culvert. The dam acts as an obstruction that passes some flow during low-flow periods, and is therefore a baseflow contributor. Photo 4-8 is an unnamed tributary to the Davidson River (Mb1) in Transylvania County and shows a reach of stream above an undersized culvert that has created an organic debris "log-jam" at a culvert inlet. Photo 4-9 is an unnamed tributary to the Neuse River (Ia2) in Wayne County and shows a straightened channel choked with aquatic vegetation. The removal of streamside area woody vegetation has resulted in shading being largely absent from this reach.

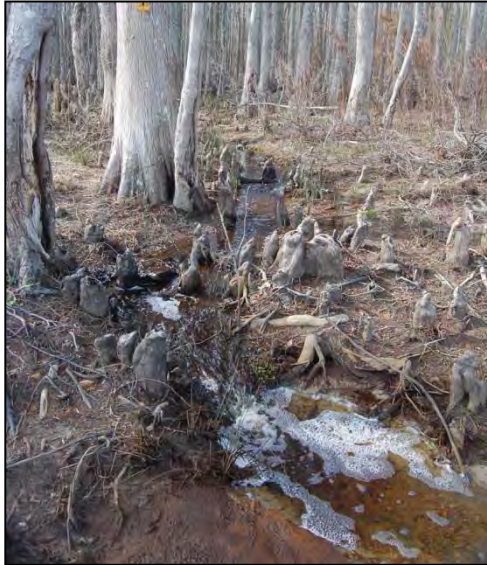
These photos provide examples of flow restrictions that have affected in-stream habitat. Photo 4-10 is an unnamed tributary to the Neuse River (Ia2) in Craven County and shows a Riverine Swamp Forest, which has developed a dense root mat that acts as a natural dam at the confluence of the tributary and the Neuse River. Photo 4-11 is an unnamed tributary to Stonyton Creek (Ia2) in Lenoir County and shows a natural debris dam upstream of roots extending across the stream bed. Note the aquatic macrophytes just upstream of the debris jam.

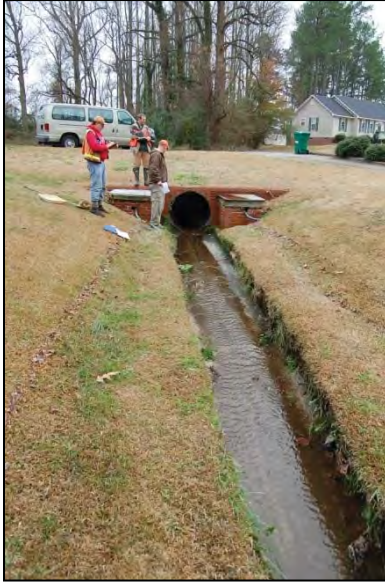
These photos provide examples of alterations to stream pattern resulting in a rating of descriptor “A.” Photo 4-12 is an unnamed tributary to Skewakee Gut (1a1), and Photo 4-13 is an unnamed tributary to Beaverdam Creek (1a2), both in Martin County. Both photos show straightened streams; the former is characterized by a concrete bed. Photo 4-14 is an unnamed tributary to the Pasquotank River (Oa2) in Camden County and shows the straightening of a stream reach downstream of a culvert to promote flow away from the culvert in a relatively flat, low-energy environment. Photo 4-15 is an unnamed tributary to Knap of Reeds Creek (Pa3) in Granville County that has been relocated and straightened at the toe of the valley wall to allow room for a wider community park. Photo 4-16 is Hewletts Creek in New Hanover County, a Tidal Marsh Stream. The large picture was taken looking north from the road crossing shown in the inset. This reach of Hewletts Creek has been relocated from the middle of the marsh to one side of the marsh; the photo inset confirms that the relocated reach is much straighter than the original channel.

When the bed and/or banks are fortified with artificial hardening such as rip-rap (Photo 4-34 and Photo 4-35), gabions (Photo 4-36), a bulkhead (Photo 4-37), wing walls (Photo 4-38), masonry (Photo 4-17, Photo 4-20, and Photo 4-27), or concrete (Photo 4-12 and Photo 4-39), an

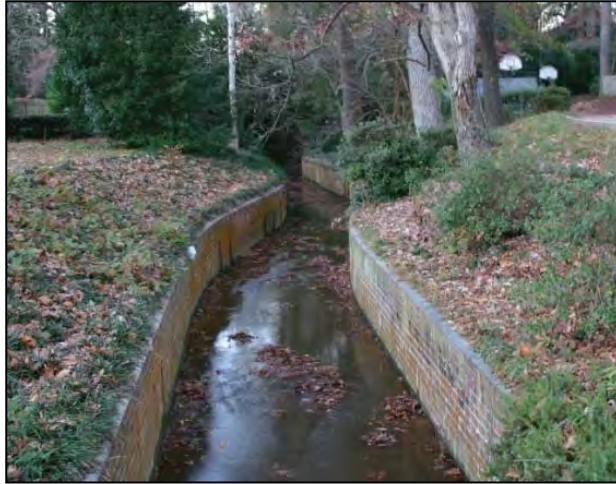
Photo 4-17 through Photo 4-19 are streams with substantially altered profiles (descriptor “A”). Photo 4-17 shows a stream with masonry banks and bed. Photo 4-18 shows a stream that has recently been cleaned out (dredged). Photo 4-19 shows a stream downstream of a recently constructed residential development that is currently characterized by sand deposits that have embedded riffles and filled pools. Photo 4-20 shows a stream with an altered pattern (Metric 3, descriptor “A”) but not a substantially altered profile (Metric 4, descriptor “B”). Also, if an appropriate profile has developed in the bottom of a previously excavated channel, the stream may be rated as descriptor “B.”

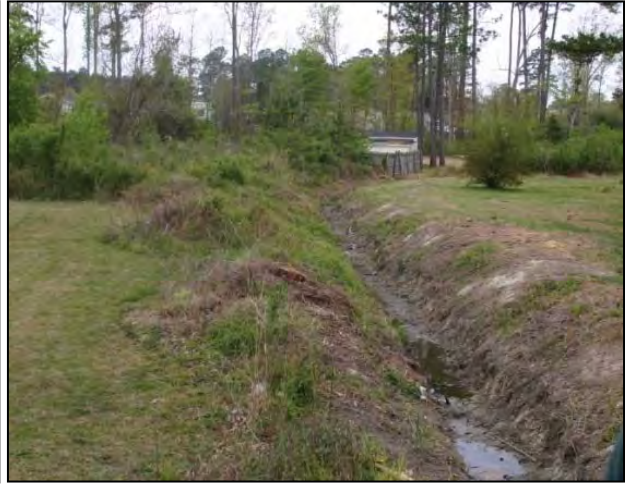
The first three photos provide examples of substantial alterations to stream profile resulting in a rating of descriptor "A." Photo 4-17 is an unnamed tributary to the Neuse River (Ia3) in Lenoir County that has been straightened and armored with masonry banks and a concrete bed. Photo 4-18 is an unnamed tributary to Conaby Creek (Oa1) in Washington County that has been straightened cleaned out as evidenced by the spoil piles. Photo 4-19 is an unnamed tributary to Buffalo Creek (Ma1) in Rutherford County in which excessive sediment deposition has embedded riffles and filled pools. Photo 4-20 is an unnamed tributary to Wesley Creek (Ma2) in Buncombe County that has been straightened and is subject to bank armoring, but is still characterized by an appropriate profile (descriptor "B").

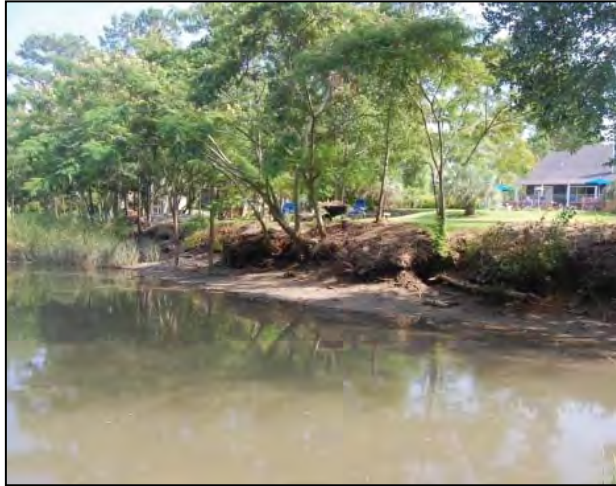
These photos provide examples of signs of active instability. Photo 4-21 is a Tidal Marsh Stream (an unnamed tributary to Middle Sound in New Hanover County) just downstream of a public boat ramp. This bank has been subject to vegetation removal and is now under-cutting and collapsing due to the energy of boat wakes. Photo 4-22 is an unnamed tributary to Lake Rogers (Pa2) in Granville County and shows a stream subject to excessive sedimentation resulting from runoff from upstream agricultural fields. Photo 4-23 is an unnamed tributary to Skewakee Gut (Ia1) in Martin County, which is characterized by maintained turf abutting a straightened channel with a concrete bed. The banks are slumping as the stream is re-establishing sinuosity. The lack of woody vegetation in the streamside area has resulted in a loss of stream shading. Photo 4-24 is Hendricks Creek (Ia4) in Edgecombe County, a reach with actively eroding banks and excessive deposition of loose sand as the result of flashy flows from an urbanized watershed. The reduction of woody vegetation on the right bank shown in the photo has resulted in degraded shading for the reach.

This situation is typically found near residences with maintained lawns (Photo 4-21), livestock grazing in pastures, around boat ramps, within utility line corridors (Photo 4-59), and under bridge crossings.

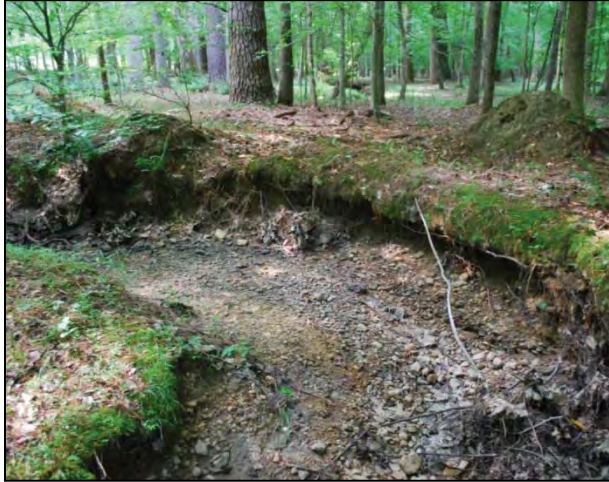
These photos provide examples of streams characterized by active bank failure. Photo 4-25 is Sal's Branch (Pa2) in Wake County, and Photo 4-26 is Mosley Creek (Ia2) in Lenoir County. Both streams are subject to flashy flows following precipitation events and are characterized by actively eroding, undercut banks with little immediate root mass and with an undercut elevation well above the typical baseflow elevation. Photo 4-27 is Horse Creek (Pa3) in Wake County, and Photo 4-28 is Little Bugaboo Creek (Ma2) in Wilkes County. The streamside areas of both of these streams are characterized by degraded vegetation and ground surface compaction resulting in accelerated surface runoff into the streams and degraded shading. Stream banks are characterized by scalloped faces resulting from high sediment loss (mass wasting). Note the calved blocks of sediment at bank toes.

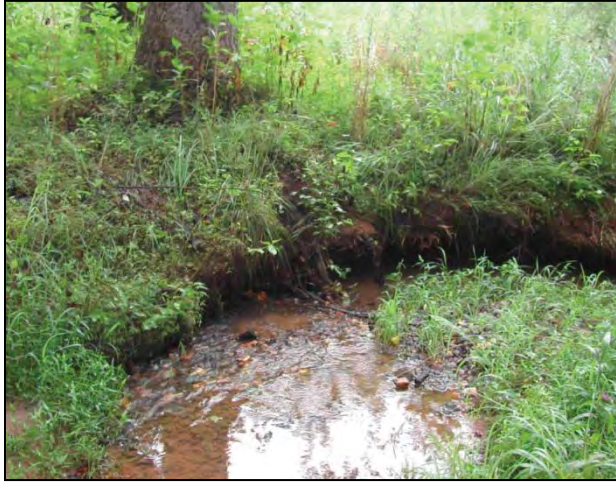
The top two photos provide examples of streams characterized by undercut banks that are viable habitat features, and not indicators of instability. Photo 4-29 is an unnamed tributary to Lyle Creek (Pa2) in Caldwell County, and Photo 4-30 is an unnamed tributary to Cane Creek (Pa2) in Alamance County flowing through a mature forest. Photo 4-31 is Horse Creek (Pa3) in Wake County, which is characterized by active surface scour and erosion with loose sediment on the bank face. Photo 4-32 is an unnamed tributary to the Cape Fear River (Ia2) in Cumberland County and shows an unstable gully resulting from concentrated stormwater runoff from adjacent impervious surfaces.

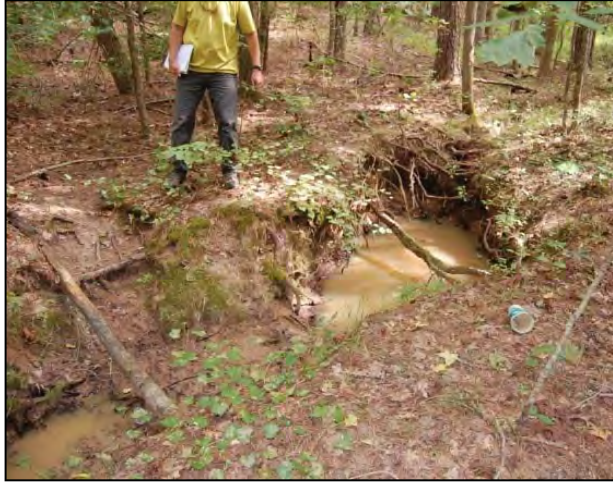
These photos provide examples of active stream instability. Photo 4-33 is an unnamed tributary to Ledge Creek (Pa1) in Granville County and shows an active head-cut down valley from a farm pond overflow outlet. This stream appears to be subject to flashy flows following precipitation events. Photo 4-34 is Hendricks Creek (Ia4) in Edgecombe County, a reach armored with rip-rap that has been destabilized by flashy flows resulting from impervious surfaces in the watershed. Photo 4-35 is Marsh Creek (Pa3) in Wake County with banks stabilized by rip-rap, excess sedimentation in the stream bed, and a parallel, maintained utility line corridor. Photo 4-36 is upper Pigeon House Creek (Pa2) in Wake County with a bank stabilized by both gabions and a wing wall.

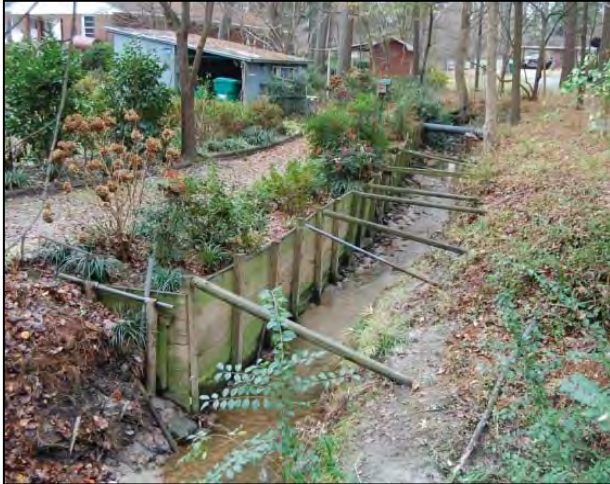
Photo 4-37 is Upper Skewakee Gut (Ia2) in Martin County, which is characterized by down-cutting and a slumping left bank supported by a bulkhead. Photo 4-38 is Crooked Run (Ia4) in Jones County. The wing walls fortify banks and contain potentially high-energy flows from the Brock Millpond spillway under N.C. Highway 58 near Trenton. Photo 4-39 is an unnamed tributary to Marsh Creek (Pa1) in Wake County and shows total armoring of a stream bed and banks in an urban setting. Photo 4-40 is a Tidal Marsh Stream (an unnamed tributary to Myrtle Grove Sound in New Hanover County), which is characterized by a left-bank retaining wall, apparently installed to expand a residential yard.

assessor should consider the stream to be unstable unless best professional judgment indicates the contrary. The structure shown in Photo 4-37 is a bulkhead, a term for a constructed wall in an unstable environment. In this instance, the bulkhead is being undermined and is collapsing. The structure shown in Photo 4-40 is a retaining wall, a term for a constructed wall in a stable environment. In this instance, the abutting intertidal zone is stable and healthy, and the retaining wall is intended to extend the high ground toward the water for a residential yard, rather than preventing erosion. In many examples of walls along Tidal Marsh Streams, these structures are not indicators of instability (bulkheads), but are indicators of a stable extension of high ground toward the water (retaining walls).

Note that descriptor “C” is appropriate for three different conditions: 1) extensive evidence of conditions that adversely affect reference interaction (for instance, the bulkhead in Photo 4-37 degrades both overbank flow and overland flow streamside area interaction, and the streams in Photo 4-49 and Photo 4-50 have down-cut well below the floodplain), 2) the expected floodplain or intertidal zone is unnaturally absent (for instance, the bulkhead supports fill in what used to be Salt/Brackish Marsh in Photo 4-40), and 3) the assessment reach is a man-made feature on an interstream divide (Photo 3-13 and Photo 3-14).

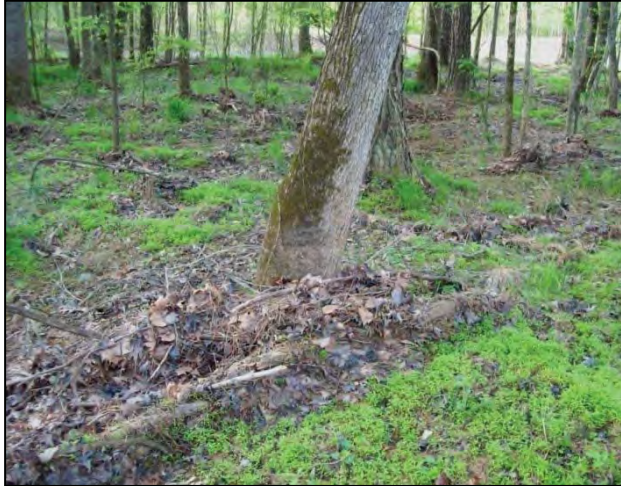
The first three photos provide evidence of overbank flow into the streamside area. Photo 4-41 is wrack lines in the streamside area of an unnamed tributary to Little Branch (Pa4) in Wake County. Photo 4-42 is recent sediment deposition in the streamside area of Mill Creek (Ia4) in Johnston County. Photo 4-43 is reclining vegetation due to overbank flows reaching the streamside area of Reedy Creek (Ia3) in Craven County. This photo was taken shortly after a large rainfall event. The view in Photo 4-44 faces upstream. This photo shows a man-made berm on the right bank of the straightened and dredged Fork Swamp (Ia3) in Pitt County. This berm is expected to hamper overland runoff and decrease the frequency of overbank flows into the right bank streamside area.

Evidence that overbank flows are accessing the streamside area includes wrack lines (Photo 4-41), surface scour, recent sediment deposition (Photo 4-42), water marks on vegetation, and reclining vegetation (Photo 4-43). Conditions that may increase or decrease (adversely affect) a stream's access to the streamside area include, but are not limited to, stream relocation, man-made berms and levees (Photo 4-44), channel down-cutting (Photo 4-6 and Photo 4-37), fill or structures (such as spoil piles [Photo 4-18], logging roads, causeways [Photo 4-6], access roads, and pipelines), man-made channelization (Photo 4-9, Photo 4-17, and Photo 4-18), dredging (Photo 4-30 and Photo 4-31), channel aggradation, bulkheads (Photo 4-37), retaining walls (Photo 4-40 and Photo 4-45), tide gates, perched culverts (Photo 2-4), weirs (Photo 2-37), flashboard risers, and excessive sedimentation (Photo 4-46).

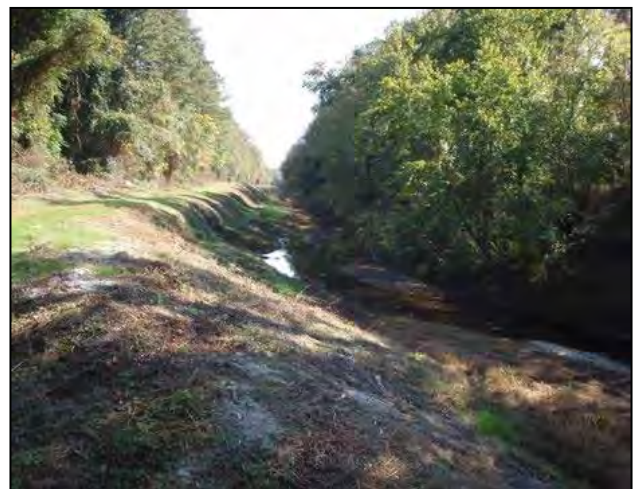
Photo 4-44

Descriptor “A” is appropriate for both banks shown in Photo 4-43. Photo 4-44, taken facing upstream, shows a straightened and down-cut tributary. Descriptor “C” is appropriate for the cleared right bank with an adjacent berm, and descriptor “B” is appropriate for the vegetated left bank. The bank visible in Photo 4-45 is evaluated as descriptor “C” due to the retaining wall. Excessive sedimentation in the streambed in Photo 4-46 increases frequency of overbank flows, resulting in evaluation as descriptor “B.” The stream visible in Photo 4-47 is slightly incised, has been straightened in the past, and is characterized by primarily agricultural field and an approximately 50-foot wide abutting mature forest buffer in the streamside area, resulting in evaluation as descriptor “B.” A lack of appropriate vegetation and the presence of pavement in the streamside area shown in Photo 4-48 resulted in an evaluation as descriptor “C” for the bank in view.

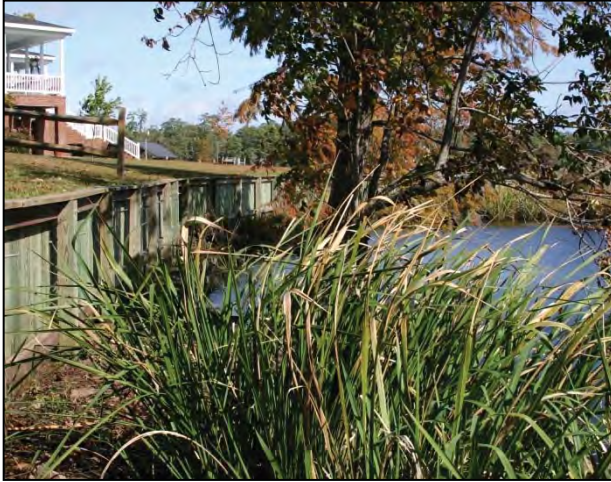
Photo 4-45 shows a retaining wall used to extend a residential yard on Brice Creek (Ia4) in Craven County. The lawn increases the rate of overland runoff, and the retaining wall decreases the frequency of overbank flooding. Photo 4-46 is an unnamed tributary to Marsh Creek (Pa2) in an urban area of Wake County subject to flashy flows due to the high coverage of impervious surfaces within the watershed. This stream is characterized by excessive sedimentation expected to embed riffles, fill pools, and increase the frequency of overbank flows. Photo 4-47 is an unnamed tributary to Stonyton Creek (Ia2) in Lenoir County. Just upstream of this site, an agricultural field is abutting the stream. The stream in view is slightly incised and has been straightened at some point in the past. An on-site investigation found evidence of irregular overbank flow (old debris piles but no recent sediment deposits). Runoff from the upslope agricultural fields is buffered by the approximately 50-foot wide mature forest abutting the stream. Descriptor “B” is appropriate for the reach in view. Photo 4-48 is Turkey Creek (Ma4) in Transylvania County, which is characterized by some down-cutting resulting in the reduced frequency of overbank flooding, and an altered streamside area resulting in increased runoff.

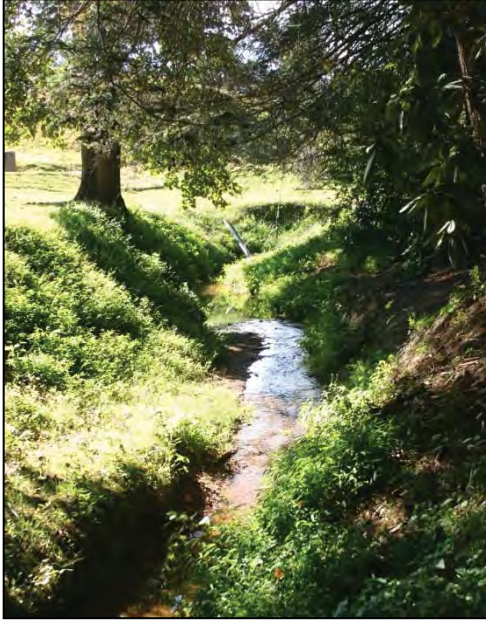
Photo 4-49 is an unnamed tributary to Second Broad River (Ma2) in McDowell County, which has down-cut well below the natural floodplain. Vegetation removed from the left bank results in degraded shading for this reach of stream. Photo 4-50 is Crabtree Creek (Pa4) adjacent to a greenway trail and commercial development in Wake County. This stream has down-cut well below the natural floodplain, the natural floodplain has received fill, and the streamside area has been modified resulting in accelerated drainage.

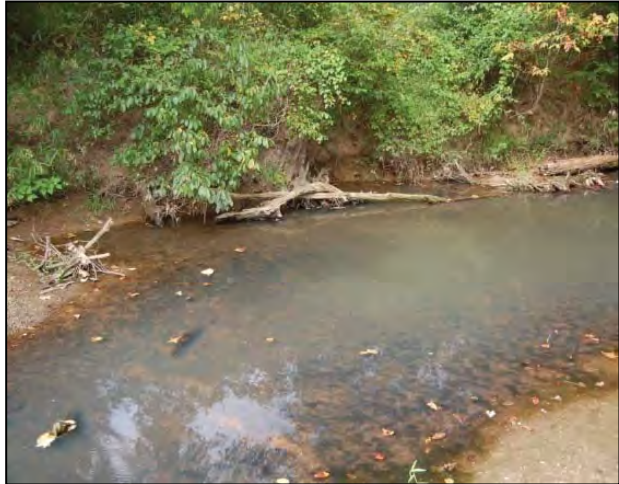
These photos provide examples of different types of discolored water that are considered water quality stressors. Photo 4-51 is milky white water in Knap of Reeds Creek (Pa4) in Granville County. Photo 4-52 shows foam on the surface of an unnamed tributary to Carvers Creek (Ia2) in Cumberland County. Photo 4-53 shows surface oil sheen (evidence of a water quality stressor) on an urban reach of an unnamed tributary to Smith Mill Creek (Ma3) in Buncombe County. Photo 4-54 shows a surface sheen on Hominy Creek (Ma4) in Buncombe County, resulting from natural-oxidizing bacteria and is not an indicator of a water quality stressor.

A: Discolored water in stream or intertidal zone (milky white [Photo 4-51], blue, unnatural water discoloration, oil sheen (Photo 4-53), stream foam [Photo 4-52])

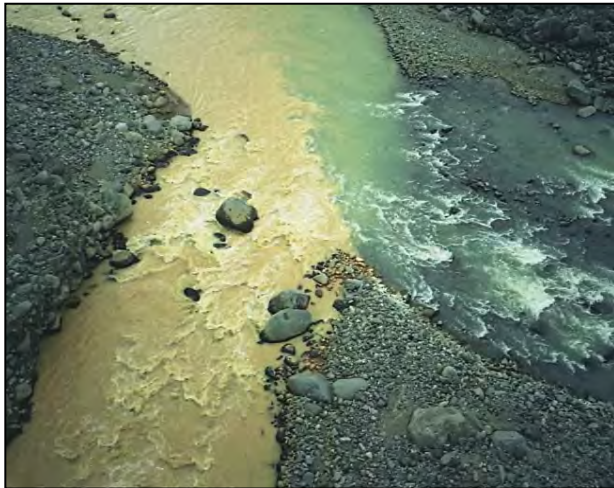
These photos show different types of water quality stressors. Photo 4-55 is the confluence of a tributary with the Tuckaseegee River (Ma4) in Jackson County. The tributary (the left fork) is carrying a heavy sediment load, evidence that it drains a watershed characterized by disturbance. Photo 4-56 shows excessive sedimentation (buried stream features) in Bush Creek (Pa2) in Chatham County.

“Turbidity” refers to the amount of solid particles suspended in water that cause light rays shining through the water to scatter. Thus, turbidity makes the water cloudy or opaque in extreme cases. Low levels of turbidity resulting solely from a rain event should not be considered a water-quality stressor. Turbidity resulting from a disturbance in the watershed (Photo 4-55) is a water-quality stressor.
