N.C. Stream Assessment Method (NC SAM)

User Manual

Prepared by the N.C. Stream Functional Assessment Team

Version 2.1
August 2015

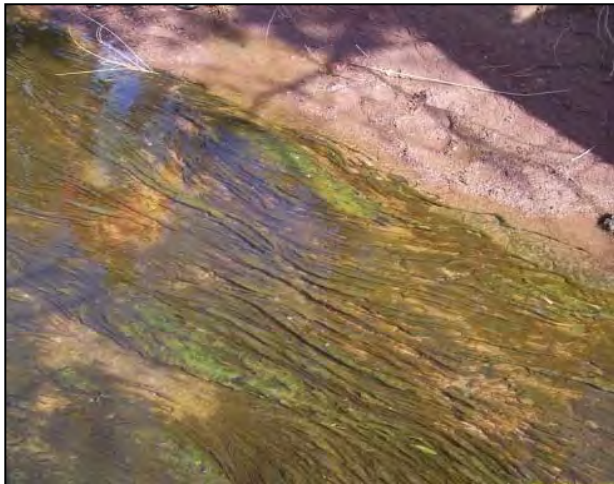
Photo 4-57 shows excessive algae over the saprolite bed in an unnamed tributary to Burdens Creek (Pa3) in Durham County. Photo 4-58 shows excessive algae on the oyster bottom of an unnamed tributary draining Harbor Island Marsh (a Tidal Marsh Stream) in New Hanover County.

The term “excessive” is important when evaluating this metric. For the purposes of this metric, algae are considered to be “excessive” when it is pervasive and readily apparent throughout the reach. Excessive algae interrupt the food chain by smothering habitat and from oxygen depletion resulting from algae death and decomposition. This condition is typically the result of a stressor such as high nutrient inputs. Photo 4-57 and Photo 4-58 show excessive algae in streams.

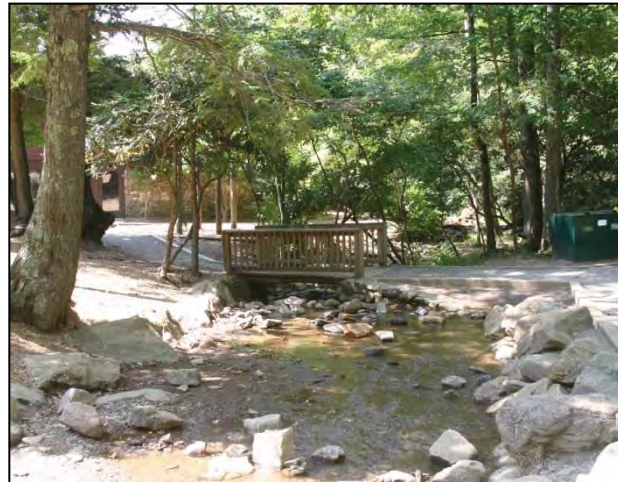
Photo 4-59 shows degraded marsh vegetation in the footprint of a former causeway within the intertidal zone of Bradley Creek (a Tidal Marsh Stream) in New Hanover County. Photo 4-60 is a reach of Kitchen Branch (Mb3) that flows through a heavily used playground in Buncombe County. The thinning of vegetation (low stem density) within this playground has resulted in degraded shading for this reach.

stressor in the blank space provided or in the “Notes/Sketch” section of the Field Assessment Form. Examples of “other” stressors include landfills and streams subject to high levels of human foot traffic (for example: a publically accessible location like a park (Photo 4-60) or an unimproved boat access point).

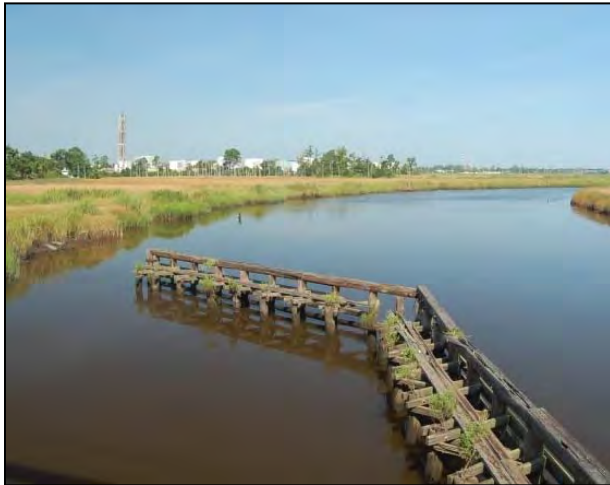
These photos provide examples of streams determined to be too large or dangerous for an assessment of habitat types, bedform, and substrate composition. Photo 4-61 is Smith Creek (a Tidal Marsh Stream) near its confluence with the Cape Fear River in New Hanover County. Photo 4-62 is the Northeast Cape Fear River (1a4) on the New Hanover/Pender County line.

“Yes” should be selected and Metrics 10, 11, and 12 should be skipped if the assessor is not able to observe or safely access the bed of the assessment reach. When “Yes” is selected, the Rating Calculator follows an alternative path for generating the functional rating that assumes a high-quality condition for these metrics. Reasons an assessor might select “Yes” for this metric include large size, inaccessibility to the bed, and extraordinarily high waters. Photo 4-61 and Photo 4-62 are streams for which “Yes” was selected.

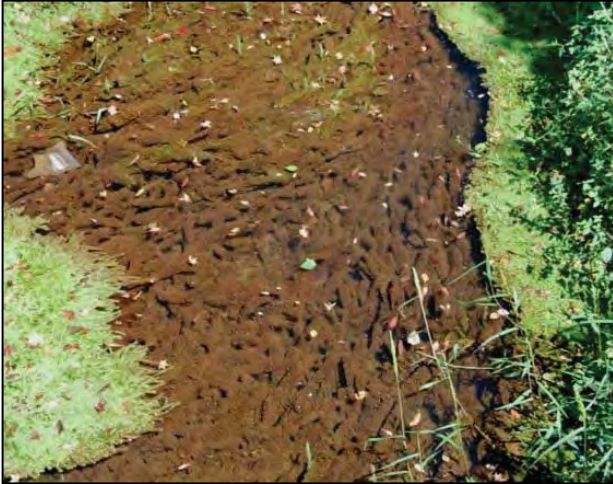
These photos provide examples of natural in-stream habitat types. Photo 4-63 is Bear Creek (Ia4) in Lenoir County, which supports dense growth of both submerged and floating aquatic macrophytes. Photo 4-64 is Little Hell Creek (Ia4) in Jones County, the bed of which supports various submerged aquatic macrophytes. Photo 4-65 is the Perquimans River (Oa4) in Perquimans County, which supports a stand of rooted and floating aquatic macrophytes near a moored periauger in a sluggish, wind-tide driven coastal stream. Photo 4-66 is an unnamed tributary to Mine Creek (Pa2) in Wake County with algal mats benefiting aquatic habitat.

“Aquatic macrophytes” are plants attached or rooted beneath the mean water surface, both submerged (Photo 4-63 and Photo 4-64) and floating (Photo 4-65). This term includes aquatic mosses, liverworts, lichens, and various flowering plants and does not include emergent plants.

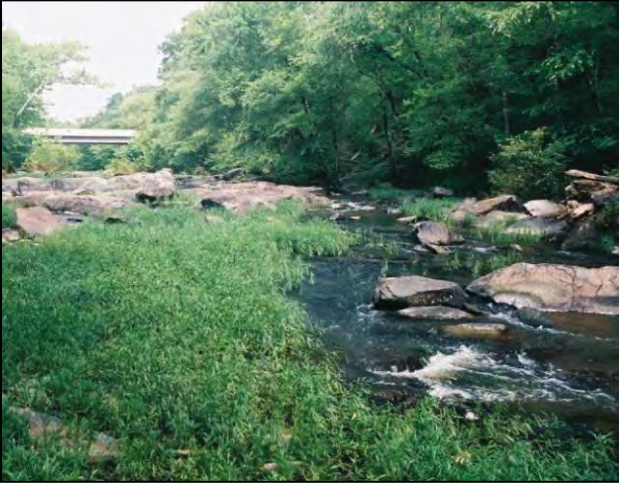
These photos provide examples of natural in-stream habitat types. Photo 4-67 is Flat River (Pa4) in Durham County, which supports a stand of aquatic macrophytes in a bed of cobble and boulders. Photo 4-68 is Little Doe Creek (Oa3) in Brunswick County, which is characterized by multiple sticks and a log. Photo 4-69 shows a leaf pack in a riffle in Kennedy Mill Branch (Ia3) in Johnston County. Photo 4-70 shows a leaf pack in a riffle in an unnamed tributary to Carvers Creek (Ia1) in Cumberland County.

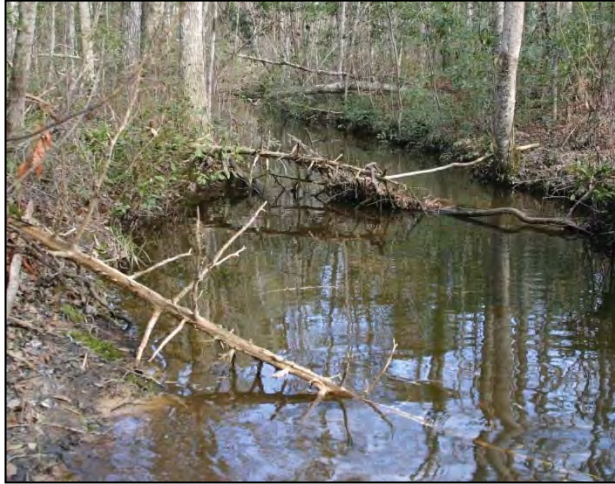
These photos provide examples of natural in-stream habitat types. Both top photographs show snags that are also acting as lap trees. Photo 4-71 is a natural channel in Honey Island Swamp (Oa3) in Brunswick County, and Photo 4-72 is the Vann Swamp Canal (Oa4) in Beaufort County. Photo 4-73 is an unnamed tributary to Crabtree Creek (Pa2) in Wake County with undercut banks benefiting aquatic habitat. Photo 4-74 is roots and root mats in banks that extend into the normal wetted perimeter on an unnamed tributary to Carvers Creek (Ia1) in Cumberland County.

A “snag” is a dead tree or part of a dead tree held fast in the bed or bank of a stream that provides aquatic habitat (Photo 4-71 and Photo 4-72).

A “lap tree” is a tree (living or dead) that extends laterally from the stream bank into the stream (Photo 4-71 and Photo 4-72). Lap trees provide wildlife access between the stream and the streamside area as well as providing habitat for aquatic life if the lap tree is at least partially underwater.

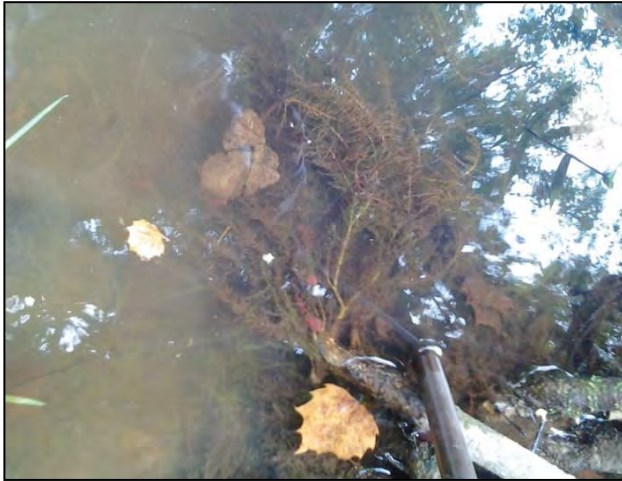
These photos provide examples of natural in-stream habitat types. Photo 4-75 shows roots and root mats in banks that extend into the normal wetted perimeter on an unnamed tributary to Belews Lake (Pa3) in Rockingham County. Photo 4-76 is an oyster bottom of an unnamed Tidal Marsh Stream within Harbor Island Marsh in New Hanover County.

A “root mat” is a mass of plant roots extending from a stream bank into the water column or along the stream bed (Photo 4-74 and Photo 4-75). Root mats and roots extending from the bank provide stability to stream beds and banks, as well as provide for aquatic habitat.

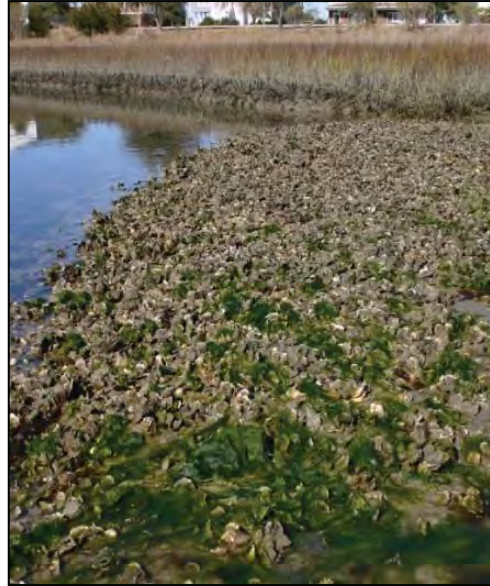
fish. Hard substrates, like oysters, rip rap, dock pilings, and boat hulls provide habitat for a wide variety of species, sanctuary for larval fish, and feeding grounds for primary predators. Photo 4-76 shows an oyster bottom within a Tidal Marsh Stream in Harbor Island Marsh near Wrightsville Beach, New Hanover County.

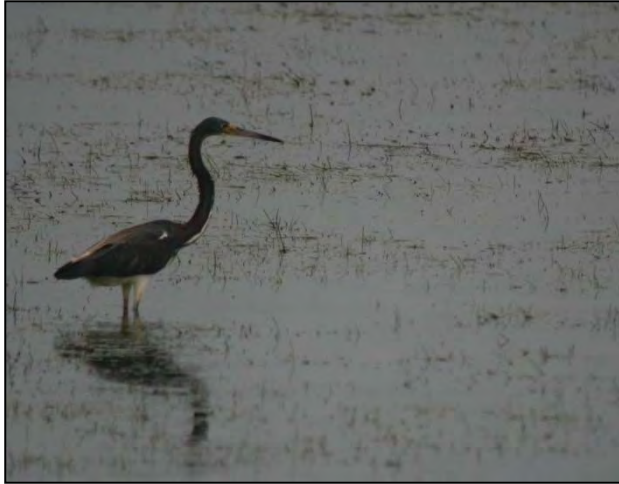
These photos provide examples of natural in-stream habitat types. The tricolor heron in Photo 4-77 is hunting for prey within a bed of submerged aquatic vegetation (SAV) on the fringe of Bogue Sound in Carteret County. Photo 4-78 is an unnamed tributary to Middle Sound (Tidal Marsh Stream) in New Hanover County, which is characterized by a natural sand bed with low-tide refugia. The bottom two photographs show vertical banks along Tidal Marsh Streams that provide natural habitat. Photo 4-79 is Hewlett's Creek in New Hanover County, and Photo 4-80 is an unnamed tributary to the North River in Carteret County.

For the purposes of NC SAM, Metric 10, the term “submerged aquatic vegetation” follows the definition used by the North Carolina Coastal Resources Commission (NCCRC): “Beds of submerged aquatic vegetation (SAV) are those habitats in public trust and estuarine waters vegetated with one or more species of submergent vegetation. These vegetation beds occur in both sub-tidal and intertidal zones and may occur in isolated patches or cover extensive areas” (15A NCAC 07H .0208 [6]). Typical species of submerged vegetation include eelgrass (*Zostera marina*), shoalgrass (*Halodule wrightii*), and widgeon grass (*Ruppia maritima*). SAV beds are defined by the presence of above-ground/bed leaves (Photo 4-77) or the below-ground rhizomes and propagules.

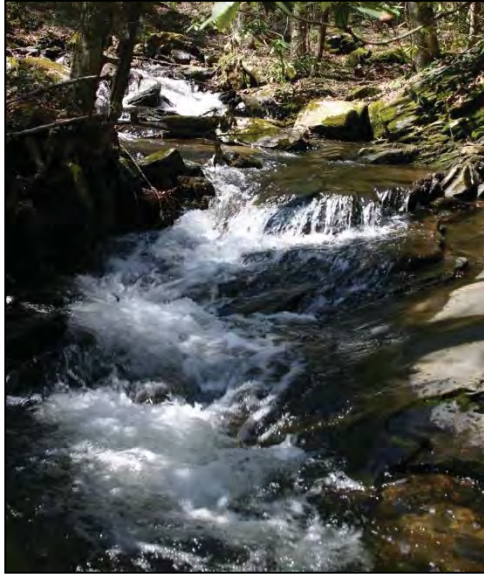
These photos provide examples of bedform types. Photo 4-81 shows a step-pool section on Three Tops Creek (Mb3) in Ashe County. Photo 4-82 shows a step-pool section in the background transitioning to a riffle section nearer the viewer on Stony Fork Creek (Pb3) in Wilkes County. Photo 4-83 shows a large step on Carvers Creek (Ib4) in Cumberland County. Photo 4-84 shows a pool-riffle sequence on Mill Creek (Mb4) in McDowell County.

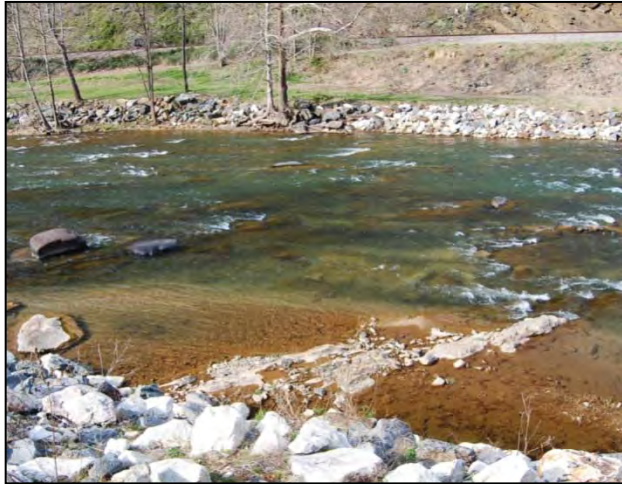
These photos provide examples of bedform types. Photo 4-85 shows a riffle section on the North Toe River (Mb4) on the Mitchell/Yancey County line. Photo 4-86 shows bedrock forming a step-pool section on an unnamed tributary to Stinking Creek (Pa2) in Chatham County. Photo 4-87 shows a riffle flowing into a pool on the Flat River (Pa4) in Durham County. Photo 4-88 shows a glide flowing into a riffle-run section on an unnamed tributary to North Deep Creek (Pa3) in Yadkin County.

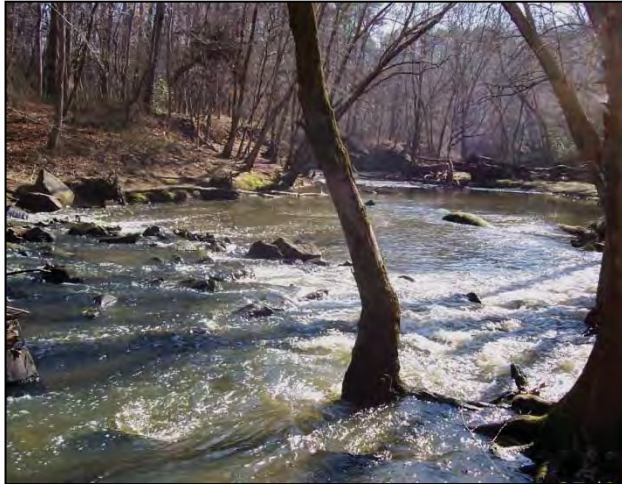
These photos provide examples of bedform types. Photo 4-89 shows a riffle-run section flowing to a pool at the bend on Crabtree Creek (Pb4) in Wake County. Photo 4-90 shows a riffle flowing into a pool on an unnamed tributary to Sycamore Creek (Pa2) in Wake County. Photo 4-91 shows a riffle-run section flowing into a pool on Sal's Branch (Pa2) in Wake County. Photo 4-92 shows a pool in a bend of Sal's Branch.

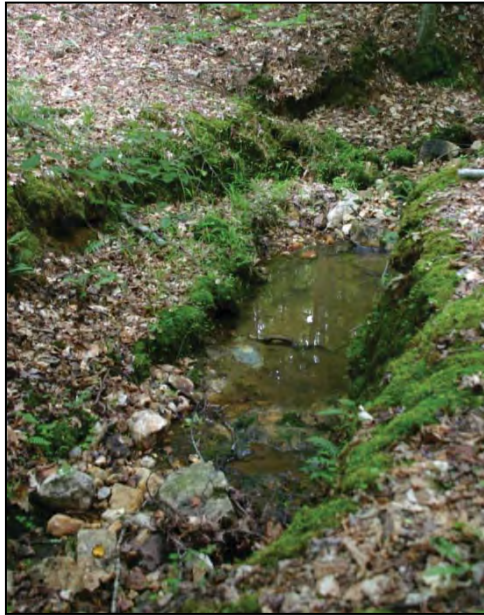
These photos provide examples of bedform types. Photo 4-93 shows a riffle-pool-riffle sequence in an unnamed tributary to Crabtree Creek (Pa1) in Wake County. Photo 4-94 shows a pool-glide section flowing into a riffle in Holly Creek (Ia3) in Edgecombe County. Photo 4-95 shows a ripple section in Batarora Branch (Ia4) in Brunswick County (note the multiple leaf packs). Photo 4-96 shows a pool-ripple-pool sequence in an interstream flat ditch that is an unnamed tributary to Pages Creek (Ia2) in New Hanover County.

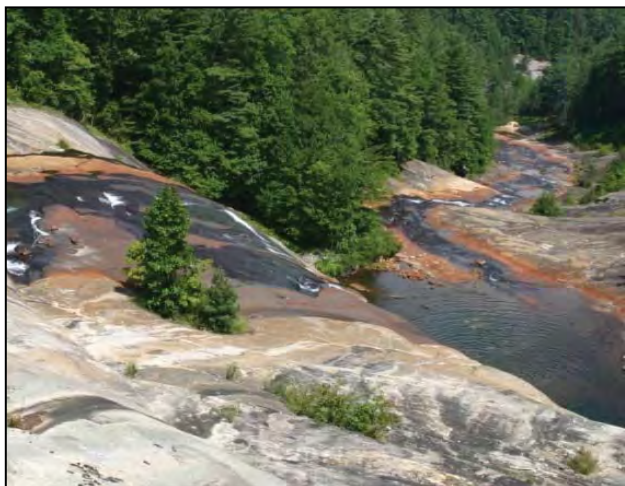
These photos provide examples of various stream substrate types. Both Photo 4-97 and Photo 4-98 show beds consisting predominantly of bedrock. Photo 4-97 is Toxaway Falls (Mb4) in Transylvania County, and Photo 4-98 is an unnamed tributary to Stinking Creek (Pa2) in Chatham County. Photo 4-99 is a reach of Crabtree Creek (Pb4) in Wake County, which is characterized by a bed of abundant bedrock and boulders. Photo 4-100 shows a bed and bank comprised predominantly of saprolite in an unnamed tributary to Burdens Creek (Pa3) in Durham County.

“Bedrock” refers to rocks partially or wholly within a stream with a diameter greater than 4096 millimeters (13.4 feet) (Photo 4-97, Photo 4-98, Photo 4-99, and Photo 4-101).

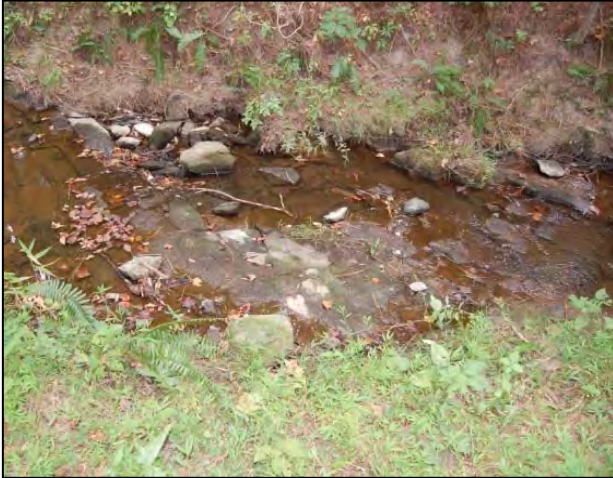
These photographs provide examples of various stream substrate types. Photo 4-101 is an unnamed tributary to Knap of Reeds Creek (Pa3) in Granville County with a bed characterized by abundant bedrock and common boulder and cobble. Photo 4-102 is an unnamed tributary to Richlands Creek (Pb1) in Wake County characterized by a bed of common boulder, cobble, and gravel. Photo 4-103 shows a northern water snake swimming among a predominance of cobble in an unnamed tributary to Stinking Creek (Pa2) in Chatham County. Photo 4-104 is an unnamed tributary to Sycamore Creek (Pa2) in Wake County with a bed of common gravel and abundant sand.

“Boulder” refers to rock fragments within a stream with a diameter between 256 and 4096 millimeters (10 inches and 13.4 feet) (Photo 4-99, Photo 4-101, and Photo 4-102).

“Cobble” refers to rock fragments within a stream with a diameter between 64 and 256 millimeters (2.5 and 10 inches) (Photo 4-101 and Photo 4-102).

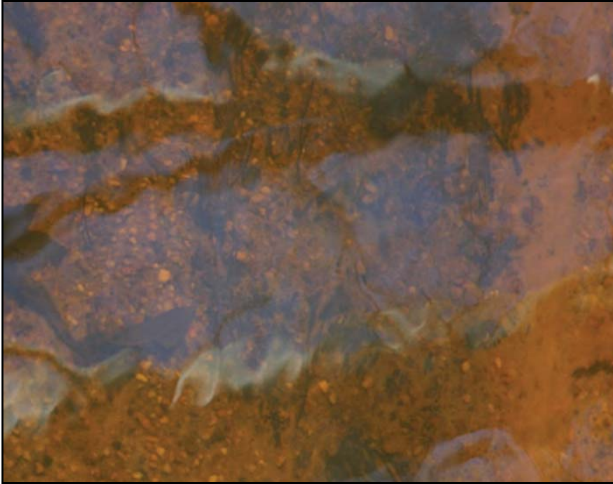
These photos provide examples of various stream substrate types. Photo 4-105 is a reach of Little Doe Creek (Oa3) in Brunswick County, a larger stream in the Outer Coastal Plain, with a bed characterized by common gravel and abundant sand. Photo 4-106 is an unnamed tributary to Town Creek (Oa1) in Brunswick County, and Photo 4-107 is an unnamed tributary to the Pasquotank River (Oa1) in Camden County, both characterized by a bed of abundant sand and detritus. Photo 4-108 is an unnamed tributary to Marsh Creek (Pa2) in Wake County, which is characterized by excessive sand deposition. The natural bed substrate of this stream is likely to be common cobble, gravel, and sand, but disturbance in the watershed has resulted in embedding of the natural substrate by excessive sand deposition – degrading aquatic habitat.

“Gravel” refers to rock fragments within a stream with a diameter between 2 and 64 millimeters (0.01 and 2.5 inches) (Photo 4-102, Photo 4-104, and Photo 4-105).

Photo 3-5, Photo 3-7, Photo 4-6, and Photo 4-105 through Photo 4-108 show streams with sand mixed in the bed substrate. Photo 4-105 through Photo 4-107 show Coastal Plain streams that have sand as a primary substrate – as expected. Photo 4-108 and Photo 4-19 show a Piedmont stream and a Mountain stream, respectively, both of which are located outside of areas known to support natural sand-bed streams, and are characterized by abundant or predominant sand in the bed. The natural bed substrate of these streams is expected to be common cobble, gravel, and sand, but disturbance in the watershed has resulted in embedding of the natural substrate by excessive sand deposition, thereby degrading aquatic habitat.

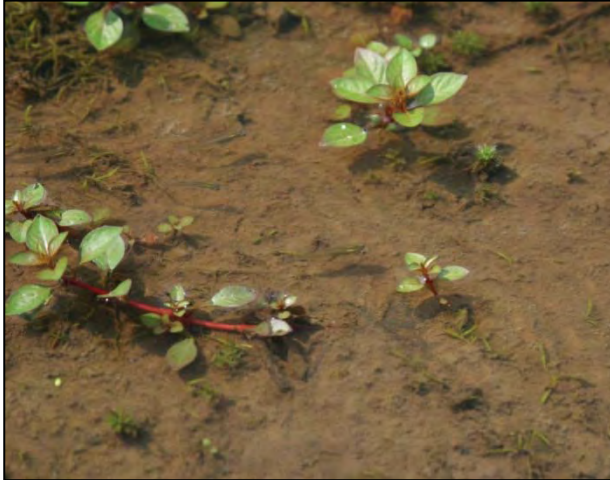
Photo 4-109 and Photo 4-110 provide examples of two stream substrate types. Photo 4-109 is an unnamed tributary to Joyce Creek (Oa3) in Camden County. This low-energy feature is a man-made ditch in an interstream divide supporting large tracts of agriculture and scattered residential development. The bed is predominantly silt. Photo 4-110 is an unnamed tributary to Little River (Ia1) in Moore County, a low-energy stream in a forested setting with a bed comprised predominantly of detritus. Photo 4-111 and Photo 4-112 show streams with stone cross vanes (in both cases, boulder) constructed as part of natural channel designs. Photo 4-111 is Holly Creek (Ia3) flowing through a golf course in Edgecombe County. Photo 4-112 is Little Sandy Creek (Pa3) in Wilkes County at Stone Mountain State Park.

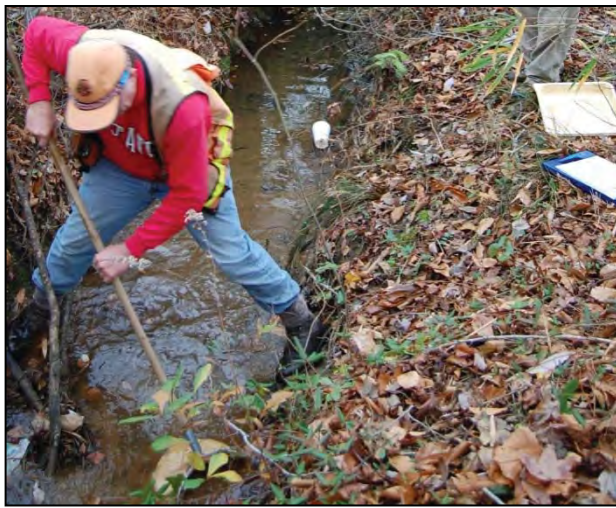
These photos depict in-stream aquatic life assessments. Guidance for conducting an assessment sufficient for the purposes of NC SAM is provided in the Metric 12 (Aquatic Life) discussion. Photo 4-113 portrays the sampling of an unnamed tributary to Beaverdam Creek (1a1) in Martin County, and Photo 4-114 portrays the sampling of an unnamed tributary to Carvers Creek (1a2) in Cumberland County.

Ideally, a search for macroinvertebrates will be conducted with a net (Photo 4-113). The size of the net itself is not terribly important; however, the mesh size should be between 0.5 and 0.8 millimeters. The net should be placed in a riffle downstream of the largest movable habitat in the deepest part of the riffle. The area upstream of the net should be agitated, usually by hand, to knock invertebrates loose and allow them to wash into the net. Detritus caught in the net can be examined in the net; however, it is easier and more efficient to put the net's contents into a white pan with a small amount of water in the bottom. The water allows invertebrates to swim (or walk), making them easier to find. The pan (or net) contents should be carefully examined for invertebrates. Observance of mussels/snail shells and larval cases/exuviae within the assessment reach indicate presence of these animals.

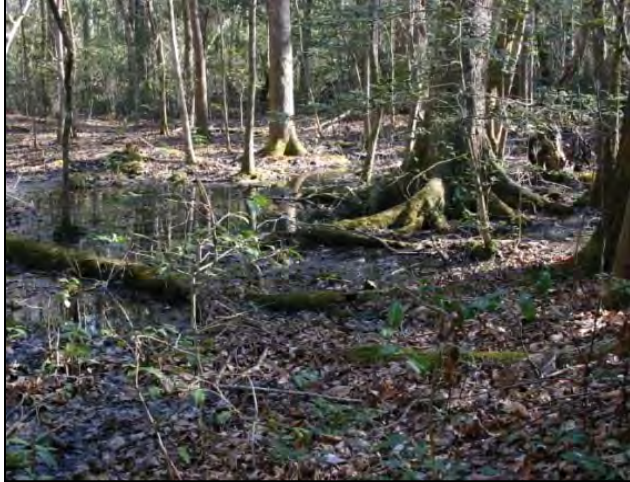
These photos provide examples of streamside area ground surface condition. Photo 4-115 is an unnamed tributary to Town Creek (Oa1) in Brunswick County, which flows through a mature forest with no alteration to streamside water storage capacity. Photo 4-116 is a downstream view of an unnamed tributary to Knap of Reeds Creek (Pa3) in Granville County. The streamside area is unaltered on the left bank and moderately altered on the right bank (vegetation strata removal, compaction from regular mowing, and a curb-and-gutter street located 200 feet from the stream). Photo 4-117 is an unnamed tributary to Joyce Creek (Oa3) in Camden County, a man-made ditch in an interstream flat with abutting active row crops on one bank and abutting maintained turf on the other. Photo 4-118 is an unnamed tributary to the Neuse River (Ia2) in Lenoir County. In both Photo 4-117 and Photo 4-118, the streamside area on both banks is characterized by severe alterations that have degraded water storage capacity and now accelerate surface runoff to the stream.

Samples of sites evaluated by the SFAT are provided in Photo 4-115 through Photo 4-118). Photo 4-115 shows a streamside area with no alteration in water storage capacity – descriptor “A.” Photo 4-116 (the view is downstream) shows a streamside area that is unaltered on the left bank – descriptor “A,” and is moderately altered on the right bank as a result of vegetation strata removal and compaction from regular mowing – descriptor “B.” Photo 4-117 shows a man-made ditch in an interstream flat, and Photo 4-118 shows a channelized stream in an urban setting. In both of these photos the streamside area on both banks is characterized by severe alteration to water storage capacity – descriptor “C.”

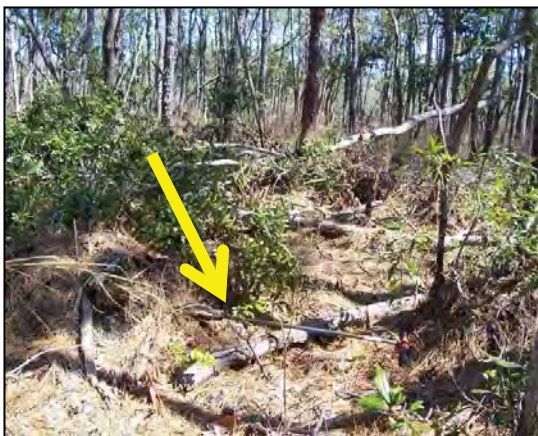
Photo 4-119

A simple method for determining the depth of depressions is to lay a stick (auger, shovel, or branch) across depressions (Photo 4-119) and estimate the average distance between the stick and the ground surface. The assessor is cautioned that overestimation of depression depth is common, and use of a tool is highly recommended. The assessor should consider all depressions in the streamside area regardless of origin (include man-made microtopography). The optimum descriptor for this metric varies with stream category. A smaller stream requires less microtopography to rate “High” than a larger stream.

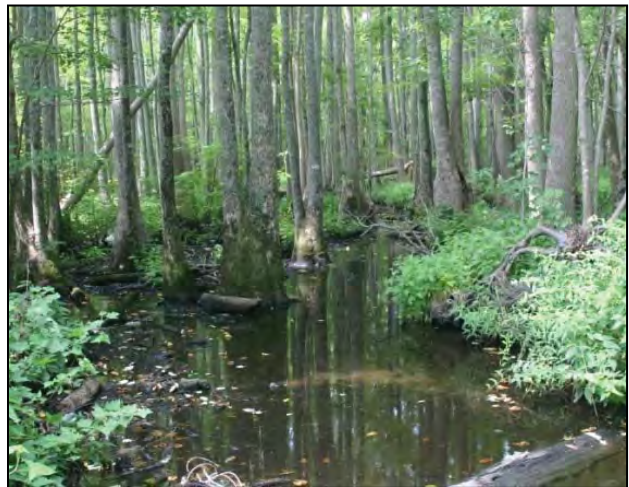
These photos provide examples of wetlands within the streamside area. Photo 4-120 is Mill Creek (Ia4) in Johnston County, and Photo 4-121 is Portohonk Creek (Oa3) in Camden County. In both examples, streamside area wetlands are the NC WAM general type Riverine Swamp Forest. The plant community visible in the latter photo is a mature forest.

“Wetlands” are areas that are inundated or saturated by surface or ground water at a frequency and duration sufficient to support, and that under normal circumstances do support, a prevalence of vegetation typically adapted for life in saturated soil conditions (Environmental Laboratory 1987). Wetlands generally include swamps, marshes, bogs, and similar areas (33 CFR 328.3(b)). The term “wetlands,” as used by NC SAM, refer to areas that meet the criteria set forth by the USACE in the *Corps of Engineers Wetlands Determination Manual* (Environmental Laboratory 1987) and the Regional Supplements (USACE 2010a and USACE 2010b). Examples of streamside area wetlands are provided in Photo 4-120 and Photo 4-121.

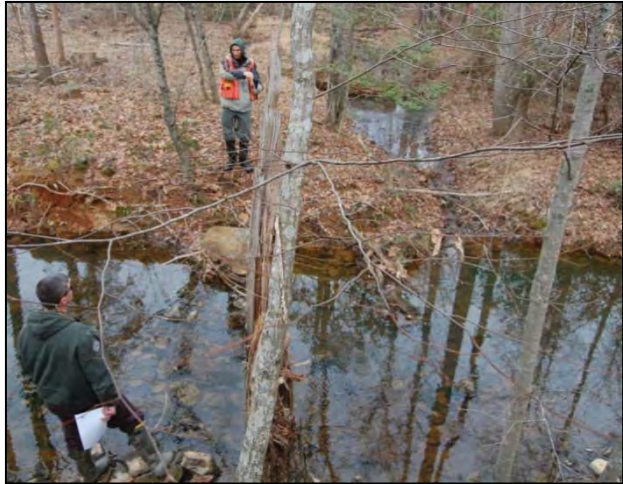
The first two photos provide examples of baseflow contributors. Photo 4-122 is an unnamed tributary (Pb1) flowing into South Prong Little River (Pb3) in Montgomery County. The unnamed tributary is a baseflow contributor to the South Prong Little River. The standing pipe in Photo 4-123 is located at a spring that forms an unnamed tributary to the Haw River (Pa1) in Alamance County. The spring itself is considered a baseflow contributor to the unnamed tributary it forms. Photo 4-124 shows a sediment basin protecting water quality in an unnamed tributary to Crabtree Creek (Pa2) in Wake County. Sediment basins are expected to provide short-term water storage only and are therefore not considered to be baseflow contributors. Photo 4-125 shows a dry detention basin at the end of its construction on the I-440 beltline in Raleigh, Wake County. This stormwater BMP is designed to treat initial runoff from precipitation events and dry out shortly thereafter; therefore, it is not considered a baseflow contributor.

A stream is a body of concentrated flowing water in a natural low area or natural channel on the land surface (15A NCAC 2B .0259 (2) (k)) or a ditch or canal. A stream may be either a natural or man-modified or man-made water course containing water at least part of the year. For the purposes of NC SAM, the terms stream and tributary are synonymous and used interchangeably, and both imply federal and/or state jurisdictional status. An example of the confluence of a small stream with a larger one is provided in Photo 4-122.

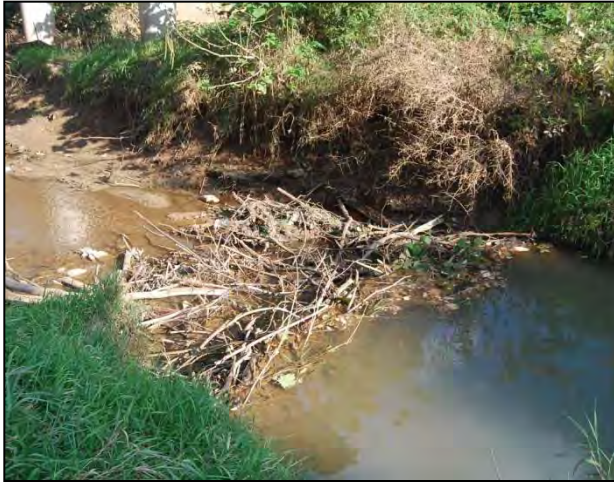
These photos provide examples of baseflow contributors. The beaver dam in Photo 4-126 is acting as an obstruction allowing the passage of flow during low-flow periods on Smith Mill Creek (Ma3) in Buncombe County, and is therefore considered to be a baseflow contributor. Photo 4-127 shows both bank seepage and algae growth on an unnamed tributary to Coinjock Bay (Oa4) in Currituck County. Photo 4-128 shows evidence of bank seepage (oxidized iron in the water column) in Knap of Reeds Creek (Pa4) in Granville County. Photo 4-129 shows both bank seepage and iron-oxidizing bacteria along the shoreline of a Riverine Swamp Forest abutting the Neuse River (Ia4) in Craven County.

Obstructions are structures that impede stream flow. For the purposes of this metric, the assessor should look for obstructions that allow for the passage of water within the assessment reach during low-flow periods such as during late summer and in drought conditions. This includes (but is not limited to) man-made structures such as leaky dams, bottom-release dams, and weirs and natural structures such as fallen trees, debris piles, and beaver dams (Photo 2-7, Photo 2-8, Photo 4-7, and Photo 4-126).

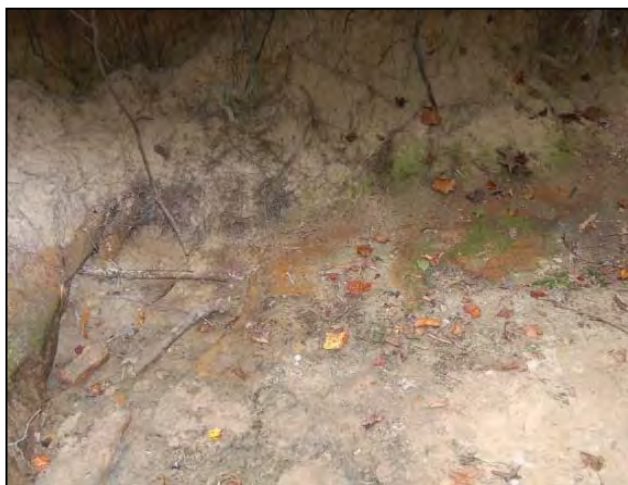
These photos provide evidence of baseflow contributors. Photo 4-130 shows evidence of bank sweating (iron-oxidizing bacteria and algae growth along the bank) in an unnamed tributary to Ledge Creek (Pa1) in Granville County. Photo 4-131 shows a reduced soil sample taken from a stream bank with a Dutch auger.

Bank sweating refers to groundwater discharging from the surface of a stream bank. Physical evidence may include soil surface glistening, oxidized iron (orange) (Photo 4-130), and algae growth (Photo 4-130).

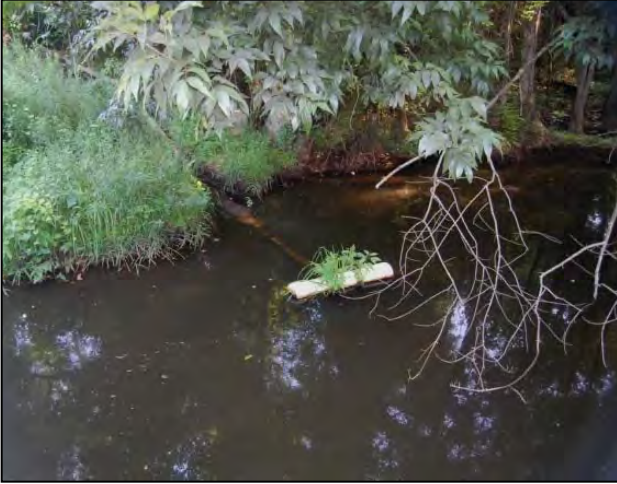
Reason for water withdrawal is not important. However, the assessor must determine that the withdrawal is “substantial” (has an effect on stream baseflow). For instance, removal of water for irrigating crops is expected to substantially affect baseflow for even a large stream. Photo 4-132 shows the inlet end of a withdrawal pipe located in an excavated pool within an Ia3 stream; the withdrawn water is used to irrigate agricultural fields. During development of this manual, SFAT members observed water withdrawal from a Size 3 stream for aquaria at a small environmental center adjacent to the stream (Photo 4-133). This withdrawal was not likely to substantially affect baseflow of the Size 3 stream and would therefore not merit the selection of this descriptor. Photo 4-134 shows a weir and transfer pipe combination used to withdraw water from a Size 2 stream to fill a pond within a public park. The source stream is small enough for this activity to be considered a baseflow detractor.

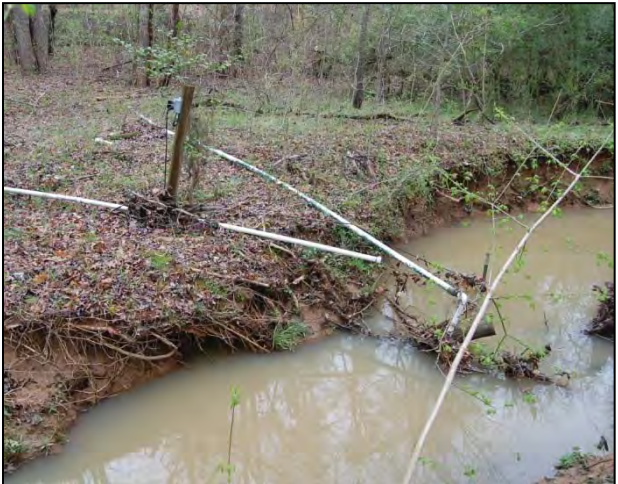
These photos provide examples of baseflow detractors. Photo 4-132 shows a pipe extending to a float in Turkey Creek (1a3) in Pender County. Photo 4-133 shows pipes used to withdraw water from Church Creek (Pa3) in Rowan County for the purpose of maintaining small aquaria associated with a nature center. Photo 4-134 shows a weir and transfer pipe combination used to collect water from an unnamed tributary to Grant's Creek (Pa2) in Rowan County for transfer to a pond in a public park. Photo 4-135 shows a stream in an urban setting, the East Prong of Slocumb Creek (1a3) in Craven County. This stream is characterized by parking lots and maintained lawn in the streamside area, unstable banks, and surface scour in the channel and streamside area.

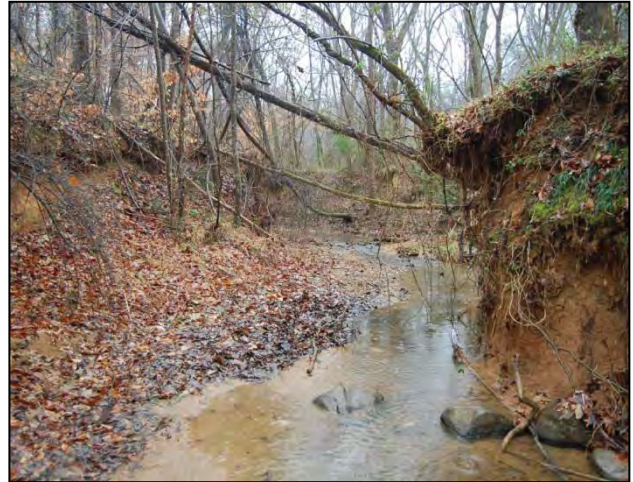
These photos provide additional examples of baseflow detractors. Photo 4-136 is Hendrick's Creek (Ia4) in Edgecombe County. Photo 4-137 is an unnamed tributary to Gum Branch (Pa3) in Mecklenburg County. Photo 4-138 is an unnamed tributary to Little River (Pa3) in Randolph County that has been relocated to the edge of the floodplain to make room for a shopping center. Photo 4-139 is the streamside area of the Linville River (Ma4) in Burke County. The first three photos show streams in urban settings subject to flashy flows that result in unstable banks and scoured channels and streamside areas. The stream in Photo 4-138 is characterized by degraded shading, and in Photo 4-139, stream shading is gone or largely absent. The last two photos provide examples of streamside area modifications that result in accelerated drainage into the stream.

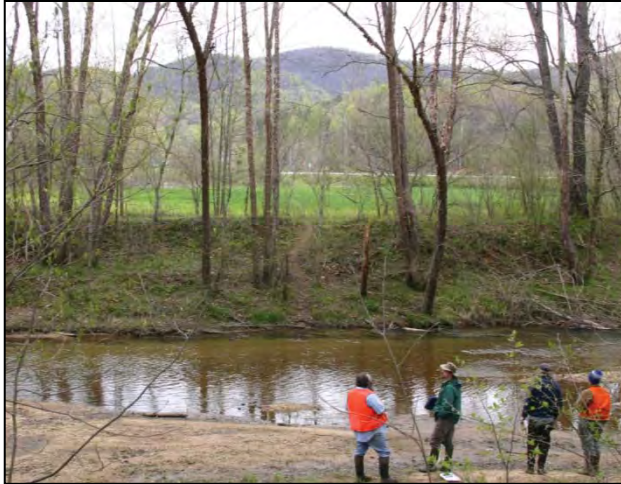
These photos provide examples of various shading scenarios. Photo 4-140 shows appropriate shading provided by a narrow stand of medium-density vegetation on Hunting Creek (Ma4) in Wilkes County. This stand of woody vegetation acts as a buffer between the stream and an active livestock pasture. Photo 4-141 is Burnt Mill Creek (Ia3) through Wallace Park in Wilmington, New Hanover County. This portion of the park retains canopy cypress trees, while the saplings, shrubs, and natural herbs have been replaced by a maintained lawn, resulting in low stem density and degraded shading. Photo 4-142 shows a dense thicket within a young secondary growth forest over an unnamed tributary to Turkey Creek (Ia1) in Pender County, which is evaluated as “degraded” shading. Photo 4-143 shows a man-made structure (Jerry’s Kitchen) providing shade for an unnamed tributary to the Atlantic Intracoastal Waterway (Oa1) near Holden Beach in Brunswick County. Although aspect results in stream shading, this case is evaluated as “degraded” shading.

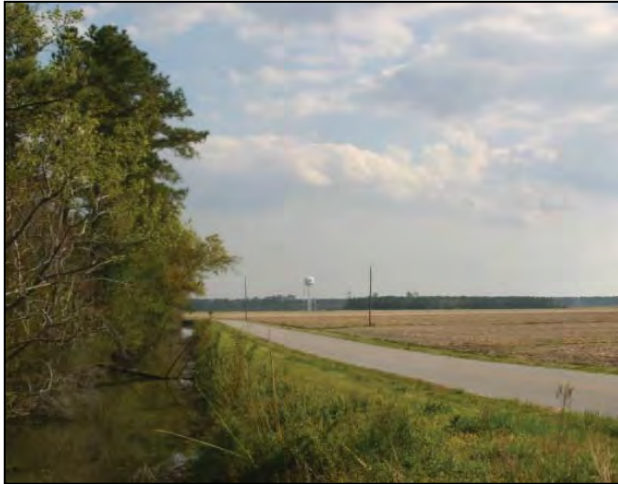
The view in Photo 4-144 is looking upstream. On the right bank, both the vegetated and wooded buffer exceeds 100 feet in width (descriptor “A”). On the left bank, the width of the vegetated buffer extends 10 feet from the top of bank to the edge of paved road. The road represents a vegetated buffer break. Since the edge of road is less than 10 feet from the top of bank the appropriate vegetated buffer descriptor is “E.” The left bank supports no wooded buffer, so the appropriate wooded buffer descriptor is “E.”

These photos provide examples of various vegetated buffer and wooded buffer widths, which are discussed in detail in the text. Photo 4-144 is an unnamed tributary to the Albemarle Sound (Oa2) in Tyrrell County. Photo 4-145 is an unnamed tributary to Bogue Sound (Oa2) in Carteret County. Photo 4-146 is an unnamed tributary to Charles Creek (Oa3) in Pasquotank County. Photo 4-147 is Raynor Mill Branch (Ia2) in Wayne County.

Photo 4-168 through Photo 4-170 show breaks in vegetation buffer continuity. In Photo 4-168, the bare ground on the right side of the photo constitutes a break in buffer continuity. In Photo 4-169 and Photo 4-170, the boat ramps and associated parking lots, respectively, constitute breaks in buffer continuity. The parking lot in Photo 4-169 extends to within 10 feet of the top of bank; therefore, the length of bank beside the parking lot is considered to be a break in buffer continuity. Other photos in the User Manual that display breaks in vegetation buffer continuity include Photo 4-118 (the vegetated area does not equal or exceed 10 feet in width on either side of the stream), Photo 4-143 (the vegetated area does not equal or exceed 10 feet in width beside the building), and Photo 4-144 (the vegetated area does not equal or exceed 10 feet in width between the canal and the road).

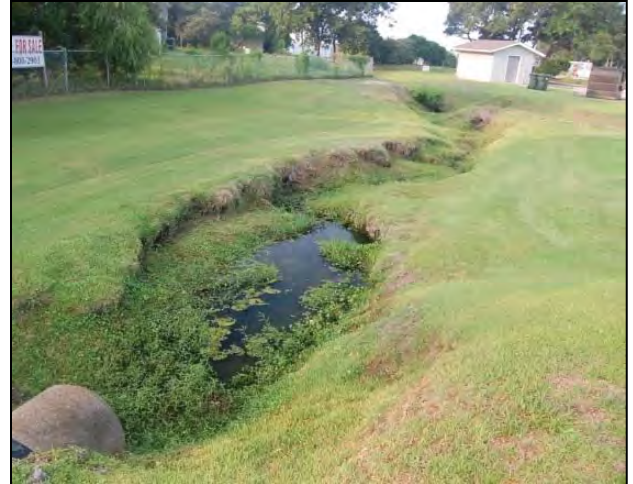
The view in Photo 4-145 is looking downstream. Both banks support vegetation that extends greater than 100 feet from the top of bank and are evaluated as descriptor “A” for vegetated buffer. The fence on the left bank demarcates the closest extent of wooded vegetation, which is approximately 20 feet from the visible reach. Since the wooded buffer is measured from the top of bank to the first break, and the distance to the closest wooded buffer is greater than 10 feet from the top of bank, the appropriate wooded buffer descriptor is “E.” The right bank lacks wooded vegetation; therefore, the appropriate wooded buffer descriptor is “E” again.

Examples of “no wooded riparian buffer or predominantly herbaceous species or bare ground” (descriptor “C”) are provided by Photo 4-9, Photo 4-18, Photo 4-23, Photo 4-39, Photo 4-117, Photo 4-118, and Photo 4-145.

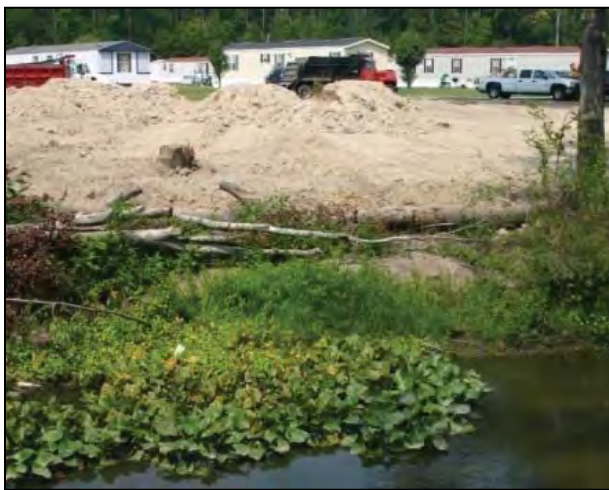
Photo 4-146

Essentially all wooded vegetation has been removed from the bank shown in Photo 4-146. A vegetated buffer extends approximately 10 feet from the top of bank. Therefore, the appropriate descriptor for both vegetated buffer and wooded buffer for this reach is “E.”

Visual examples of “little or no vegetation” are provided by Photo 4-118 and Photo 4-146. The former is located in an urbanized area of Kinston and is characterized by a less than 10-foot wide strip of maintained lawn. The latter is located in a rural, residential area and is again characterized by a less than 10-foot wide strip of vegetation.

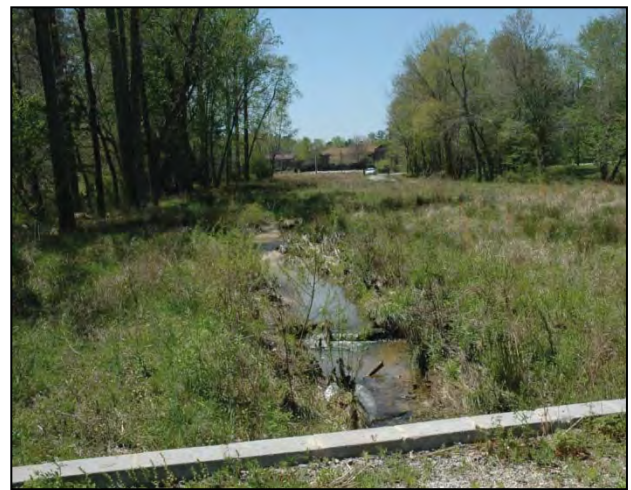
The view in Photo 4-147 is looking upstream. Both banks of the visible reach support vegetation for more than 100 feet from the top of bank and are evaluated as descriptor “A” for vegetated buffer. The average distance to wooded buffer on the right bank is between 10 and 15 feet, and the average distance to wooded buffer on the left bank is over 40 feet. Wooded buffer is measured from the top of bank to the first break, and since the first 10 feet from the top of bank is lacking wooded vegetation, the appropriate wooded buffer descriptor is “E” for both banks.

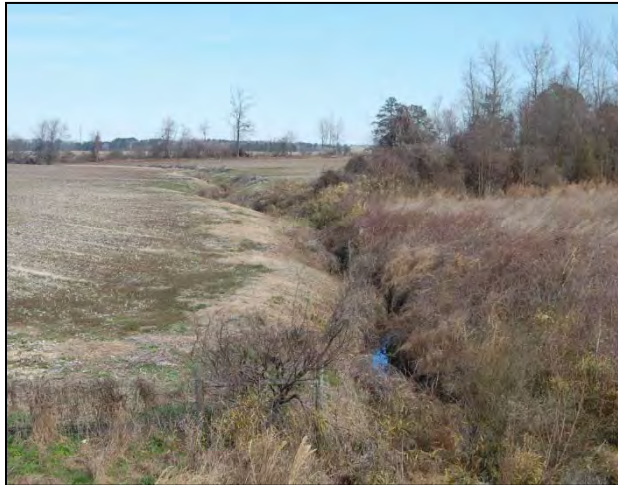
The view in Photo 4-148 is looking upstream. The right bank streamside area is maintained as an agricultural field with an approximately 10 foot wide maintained herbaceous strip abutting the stream. Since this area is dominated by vegetation, the appropriate descriptor is “A” for vegetated buffer. If the agricultural field had recently been plowed, removing the vegetation within the field and leaving only the 10 foot wide herbaceous strip, the appropriate descriptor would be “E.” The left bank streamside area supports vegetation for more than 100 feet and is evaluated as descriptor “A” for vegetated buffer. The left bank streamside area supports scattered woody vegetation, but woody vegetation is not dominant, so the appropriate descriptor is “E.”

These photos provide examples of various vegetated buffer and wooded buffer widths, which are discussed in detail in the text. Photo 4-148 is an unnamed tributary to Briery Run (1a3), and Photo 4-149 is an unnamed tributary to Falling Creek (1a2), both in Lenoir County. The unnamed tributary to Falling Creek has been excavated in an interstream divide.

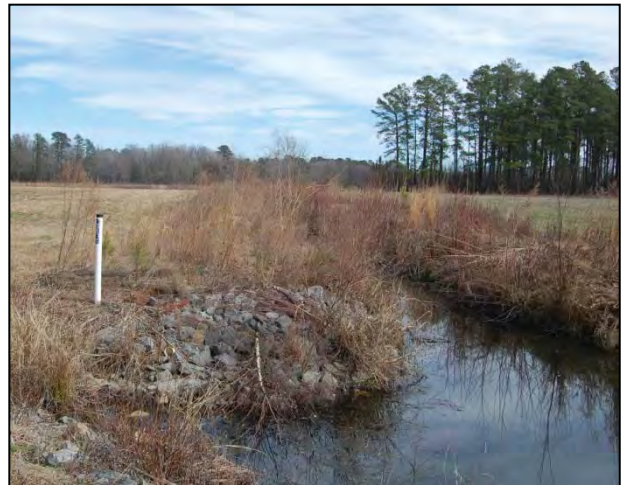
The view in Photo 4-149 is looking upstream. Both banks support narrow strips (less than 10 feet wide) of irregularly maintained shrubs and then agricultural fields dominated by herbaceous vegetation. Therefore, the appropriate descriptor for vegetated buffer is “A,” and the appropriate descriptors would be “E” for both vegetated and wooded buffer.

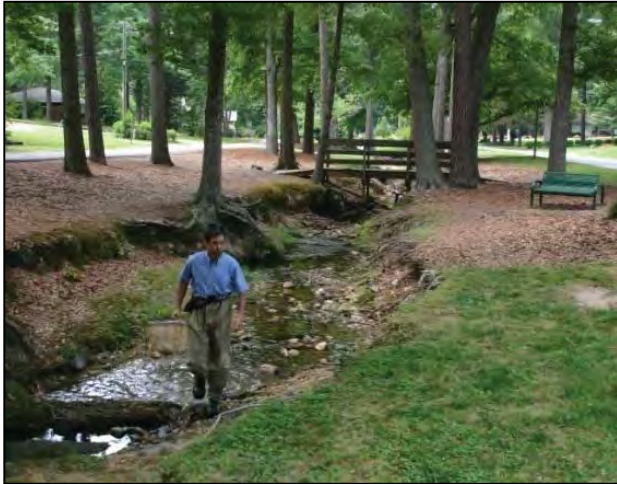
Photo 4-150 provides an example of “non-mature woody vegetation or modified vegetation structure” on both banks. This site is a park within a residential subdivision in Cary, NC. The plant community is characterized by scattered trees over a maintained lawn (shrubs and saplings have been removed), resulting in an appropriate buffer structure descriptor of “B” for both banks. Other visual examples of descriptor “B” are provided by Photo 2-19, Photo 4-24, Photo 4-31, Photo 4-138, and Photo 4-141.

These photos provide examples of disturbed buffer structure as discussed in the text. Photo 4-150 is an unnamed tributary to Swift Creek (Pa1) in a residential development in Wake County. The streamside area wooded vegetation is maintained at a low stem density. Photo 4-151 and Photo 4-152 show streamside areas of two reaches of Chappel's Creek (Pa3) in Person County. The streamside area of the former is characterized by active livestock pasture with a single line of trees on stream banks; the streamside area of the latter is within a maintained utility line corridor dominated by shrubs. Photo 4-153 shows a reach of Rocky Creek (Pa2) along a road shoulder in Wake County bounded to one side by mature forest and to the other by maintained herbaceous vegetation.

“Low stem density” is appropriate when wooded buffer has been degraded (such as a vegetative community lacking expected strata or one that has been thinned) relative to expectations for the streamside area vegetation. Examples of low stem density (descriptor “B”) are provided by Photo 2-39, Photo 3-8, Photo 4-60, Photo 4-141, Photo 4-150, Photo 4-152, Photo 4-166, and Photo 4-167.

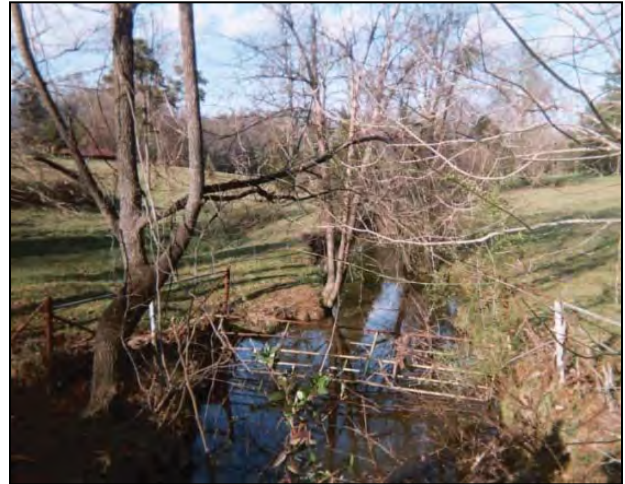
Photo 4-151 provides an example of “herbaceous vegetation with or without a strip of trees < 10 feet wide” on both banks. This photo shows a stream with pasture on both banks characterized by herbaceous vegetation with a strip of trees; the appropriate buffer structure descriptor for both banks is “C.” Other visual examples of descriptor “C” are provided by Photo 2-17, Photo 2-21, Photo 2-38, and Photo 4-48.

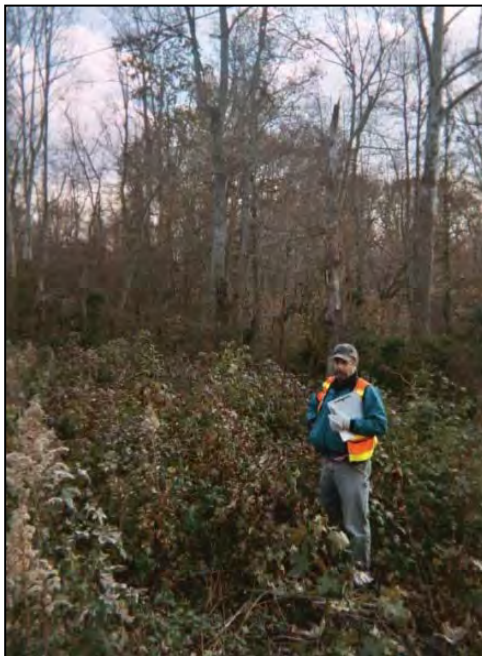
Photo 4-152 provides an example of “maintained shrubs.” This photo shows a streamside area under a regularly maintained utility line corridor that is dominated by shrubs; therefore, the appropriate buffer structure descriptor is “D.” Another visual example of descriptor “D” is provided by Photo 4-111, which shows a stream crossing a golf course fairway. The wooded buffer is maintained in a low, shrub state to ease the passage of golf balls.

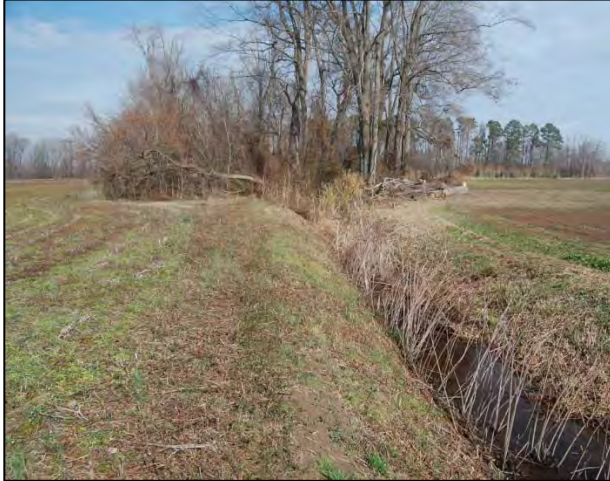
The top two photos provide examples of row crops in the streamside area. Photo 4-154 is a downstream view of an excavated unnamed tributary to Stonyton Creek (1a2) in Lenoir County. The reach in the foreground is characterized by row crops within 30 feet of the stream and a narrow, maintained herbaceous assemblage abutting both banks, while the reach in the background is characterized by row crops within 30 feet of the stream on both banks but separated from the stream by “non-mature woody vegetation” on the left bank and “mature forest” on the right bank. Photo 4-155 is an excavated unnamed tributary to New River (1a3) in Onslow County. This reach is situated in an agricultural field that has lain fallow for a year. Photo 4-156 is Holly Creek (1a3) in Edgecombe County where the stream traverses a golf fairway. The reach in the foreground is characterized by maintained turf abutting both banks, while the reach in the background is characterized by maintained turf within 30 feet of the stream but separated from the stream by “non-mature woody vegetation.” Photo 4-157 is Elk Creek (Ma3) in Ashe County. This stream is characterized by abutting pasture with active livestock use.

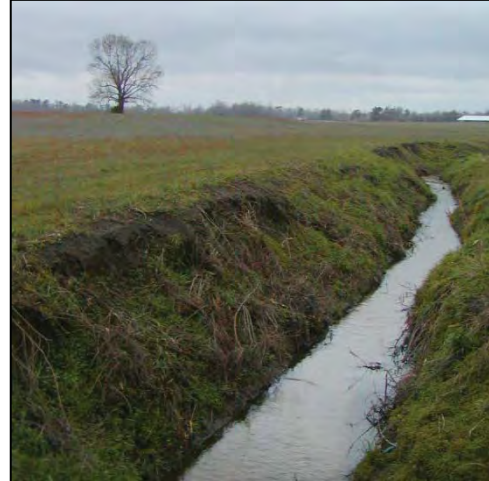
Photo 4-155 shows an excavated and straightened stream in an agricultural field at the upper end of the drainage basin. This agricultural field has lain fallow for a year and currently supports herbaceous vegetation interspersed with stubble from a recent crop. In this case, both banks can be rated as “row crops, abuts” (descriptor “A” in both the “LB” and “RB” columns under “Abuts”).

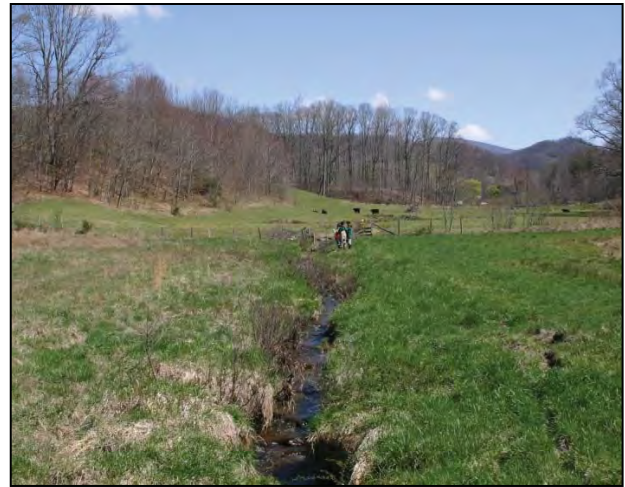
Photo 4-157 through Photo 4-159 show streams characterized by abutting active pasture. The appropriate descriptor for these examples is “D” in both the “LB” and “RB” columns under “Abuts.” Function degradation is apparent in both of the latter two photos (a dead cow on the bank in the first and bank and streamside area erosion and aquatic vegetation choking the channel in the second).

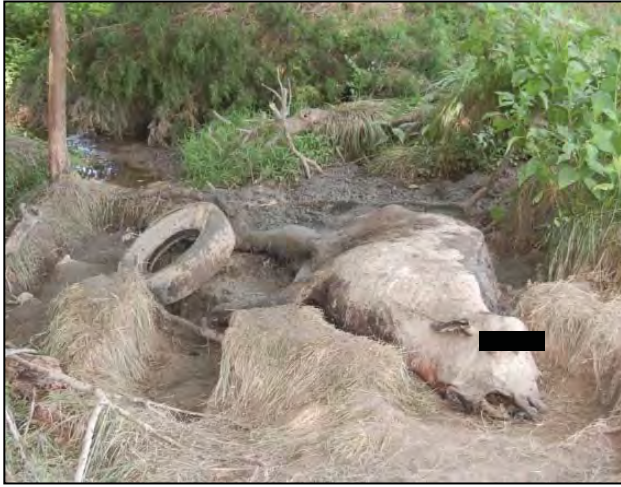
These photos provide examples of various buffer stressors. Photo 4-158 is an unnamed tributary to Back Creek (Pa2) in Mecklenburg County. This stream is characterized by abutting pasture with active livestock use and refuse dumping. Photo 4-159 is an unnamed tributary to the New River (Ia2) in Onslow County where the stream has been excavated within an active cow pasture on an interstream divide. Photo 4-160 is the Little River (Pa4) in Randolph County where an active cow pasture extends to within 30 feet of the stream, but access to the stream is denied by a fence. Photo 4-161 is a downstream view of an unnamed tributary to Squirrel Creek (Ma2) in Avery County. The left bank supports a Christmas-tree plantation (horticulture) within 30 feet of but not abutting the stream.
