N.C. Stream Assessment Method (NC SAM)

User Manual

Prepared by the N.C. Stream Functional Assessment Team

Version 2.1
August 2015

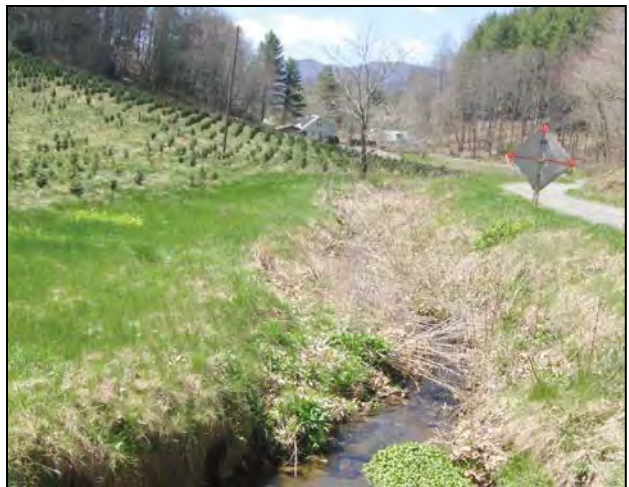
An example of horticultural uses is a Christmas tree farm. Photo 4-161 shows a Christmas tree farm within 30 feet of but not abutting the stream. The appropriate descriptor for this example is “C” in the “LB” column under “30-50 feet.” The maintained grass abutting each side of the stream would only be considered maintained turf if evidence of the use of fertilizer, pesticides, and/or herbicides is observed on site or learned of from a knowledgeable source.

These photos provide examples of various buffer stressors. Photo 4-158 is an unnamed tributary to Back Creek (Pa2) in Mecklenburg County. This stream is characterized by abutting pasture with active livestock use and refuse dumping. Photo 4-159 is an unnamed tributary to the New River (Ia2) in Onslow County where the stream has been excavated within an active cow pasture on an interstream divide. Photo 4-160 is the Little River (Pa4) in Randolph County where an active cow pasture extends to within 30 feet of the stream, but access to the stream is denied by a fence. Photo 4-161 is a downstream view of an unnamed tributary to Squirrel Creek (Ma2) in Avery County. The left bank supports a Christmas-tree plantation (horticulture) within 30 feet of but not abutting the stream.

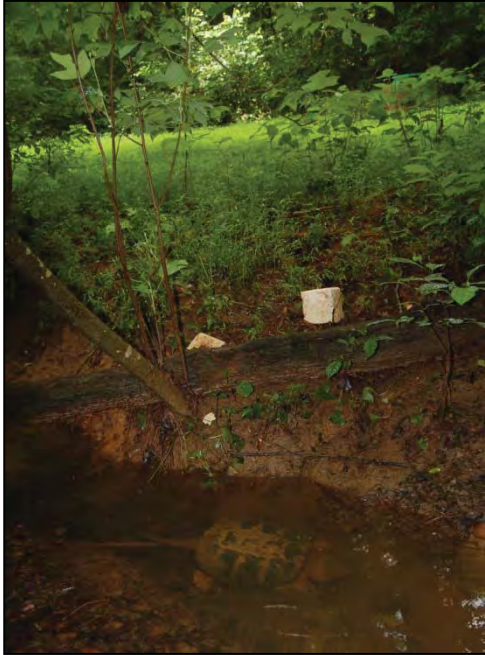
Photo 4-162 and Photo 4-163 provide an example of a stressor abutting a stream that does not meet the criteria to be evaluated for this metric. Photo 4-162 shows a parallel, maintained utility line abutting a stream, and Photo 4-163 shows a perpendicular crossing of a maintained utility line over a stream. Although these utility lines appear to be regularly disturbed and both support vegetation dominated by a non-native, invasive species, Japanese grass (*Microstegium vimineum*), the circumstances do not meet the criteria of this metric (land uses considered to degrade water quality through runoff of nutrients and chemicals associated with fertilizers,

Photo 4-162 is an unnamed tributary to Wildcat Branch (Pa2) in Wake County and is characterized by a parallel, abutting, maintained utility corridor. Photo 4-163 is an unnamed tributary to Crabtree Creek (Pa1) in Wake County and is characterized by a perpendicular crossing of a maintained utility corridor. However, as described above, neither of these streams qualifies for use of this metric.

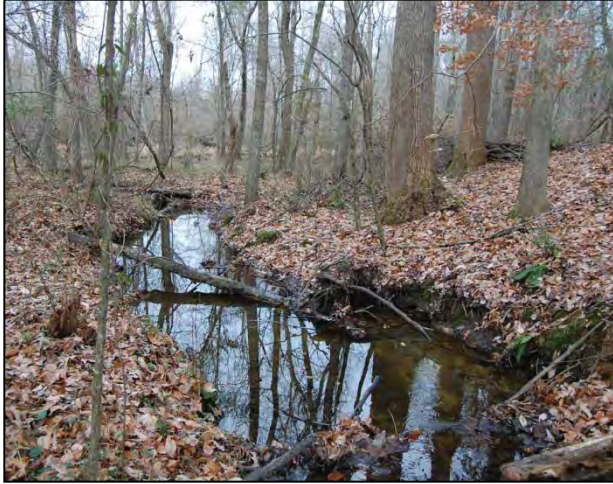
These photos provide examples of stem density. The upper two photos provide examples of “medium to high stem density”, and the lower two photos provide examples of “low stem density.” Photo 4-164 is an unnamed tributary to Beaverdam Creek (Ia2) in Martin County. Photo 4-165 is an unnamed tributary to Crabtree Creek (Pa2) in Wake County. Photo 4-166 is a floodplain park adjacent to an unnamed tributary to Knap of Reeds Creek (Pa3) in Granville County. Photo 4-167 is an unnamed tributary to Burnt Coat Swamp (Ia2) flowing through Randolph Park in Enfield, Halifax County.

“Medium to high stem density” is appropriate if the streamside area wooded buffer is in reference condition or is relatively undisturbed. Examples of medium to high stem density (descriptor “A”) are provided by Photo 3-1, Photo 3-3, Photo 4-71, Photo 4-115, Photo 4-121, Photo 4-140, Photo 4-164, and Photo 4-165.

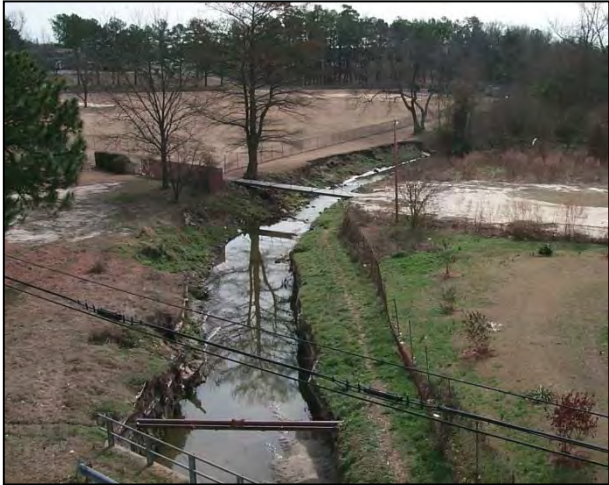
Photo 4-168 through Photo 4-170 show breaks in vegetation buffer continuity. In Photo 4-168, the bare ground on the right side of the photo constitutes a break in buffer continuity. In Photo 4-169 and Photo 4-170, the boat ramps and associated parking lots, respectively, constitute breaks in buffer continuity. The parking lot in Photo 4-169 extends to within 10 feet of the top of bank; therefore, the length of bank beside the parking lot is considered to be a break in buffer continuity. Other photos in the User Manual that display breaks in vegetation buffer continuity include Photo 4-118 (the vegetated area does not equal or exceed 10 feet in width on either side of the stream), Photo 4-143 (the vegetated area does not equal or exceed 10 feet in width beside the building), and Photo 4-144 (the vegetated area does not equal or exceed 10 feet in width between the canal and the road).

These photos provide examples of breaks in continuity of vegetated buffers. Photo 4-168 is Atkins Branch (1a3) in Lenoir County, and the non-vegetated, sandy area is considered a buffer break. Photo 4-169 is the Roanoke River (1a4) on the Martin/Bertie County line, where the boat ramps and associated parking lot constitute a buffer break. Photo 4-170 is an unnamed tributary to Bear Swamp (1a2) in Robeson County, where the parking lot less than 10 feet from the stream constitutes a buffer break.

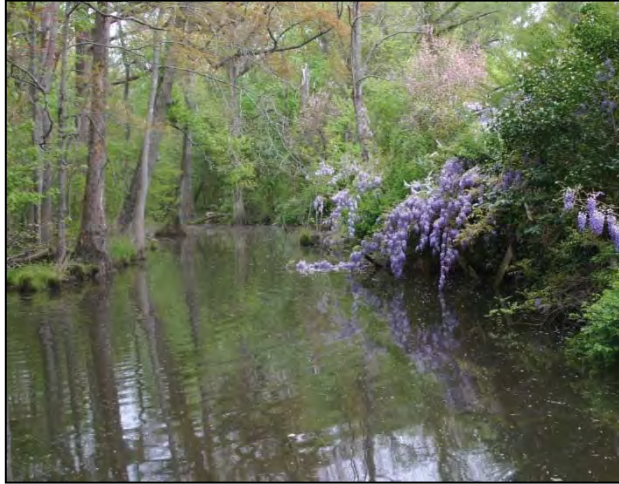
Photo 4-171 through Photo 4-174 show various examples of vegetative composition. In Photo 4-171 (the view is downstream), the left bank meets the criteria of descriptor “A.” The right bank supports dense stands of Chinese privet (*Ligustrum sinense*) intermixed with wisteria (*Wisteria* sp., blooming), both non-native invasive species dominating the first 100 feet measured perpendicular from the top of bank, which matches descriptor “C” (communities with non-native invasive species dominant over a large portion of expected strata). Photo 4-172 shows a streamside area characterized by saplings and a few trees of species typical of recently disturbed areas, vegetation composition that “...indicates disturbance in terms of species diversity or proportions, but is still largely composed of native species. This may include

These photos provide examples of vegetative composition. Photo 4-171 is a view facing downstream on Conaby Creek (Oa4) in Washington County. The left bank vegetation is relatively undisturbed, while the right bank supports non-native, invasive species (wisteria [*Wisteria floribunda*]) over a large portion of the expected strata. Photo 4-172 is the streamside area of an unnamed tributary to McPherson Creek (Pa2) in Cumberland County. This community is composed of woody native species that developed after clear-cutting. Photo 4-173 is a reach of the Vann Swamp Canal (Oa4) in Beaufort County. In this example, streamside area timber has recently been harvested. Photo 4-174 is an unnamed tributary to the South Fork Catawba River (Pb1) in Gaston County. In this example, vegetation is severely disturbed and is dominated by non-native, invasive species (kudzu).

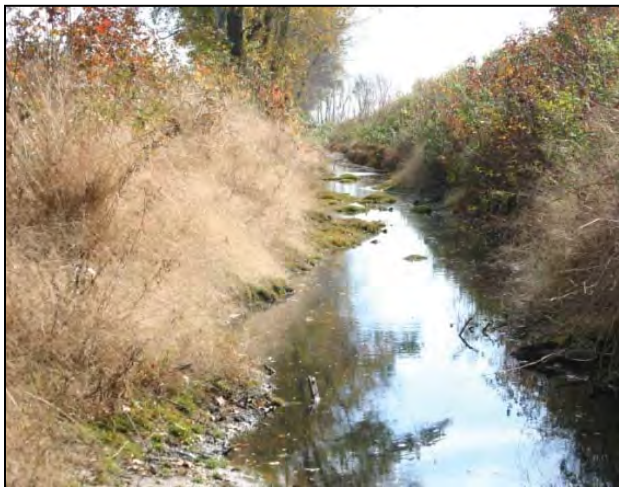
communities of weedy native species that develop after clear-cutting or clearing,” matching descriptor “B.” Photo 4-173 shows streamside area vegetation recovering from a clear-cut that is currently characterized by the term “Mature canopy is absent,” resulting in a rating of “C.” Photo 4-174 shows a reach with the streamside area dominated by kudzu (*Pueraria lobata*) and little to no other vegetation. This streamside area is characterized as “Vegetation is severely disturbed in terms of species diversity or proportions. Mature canopy is absent or communities with non-native invasive species dominant over a large portion of expected strata or communities inappropriately composed of a single species,” which matches descriptor “C.”

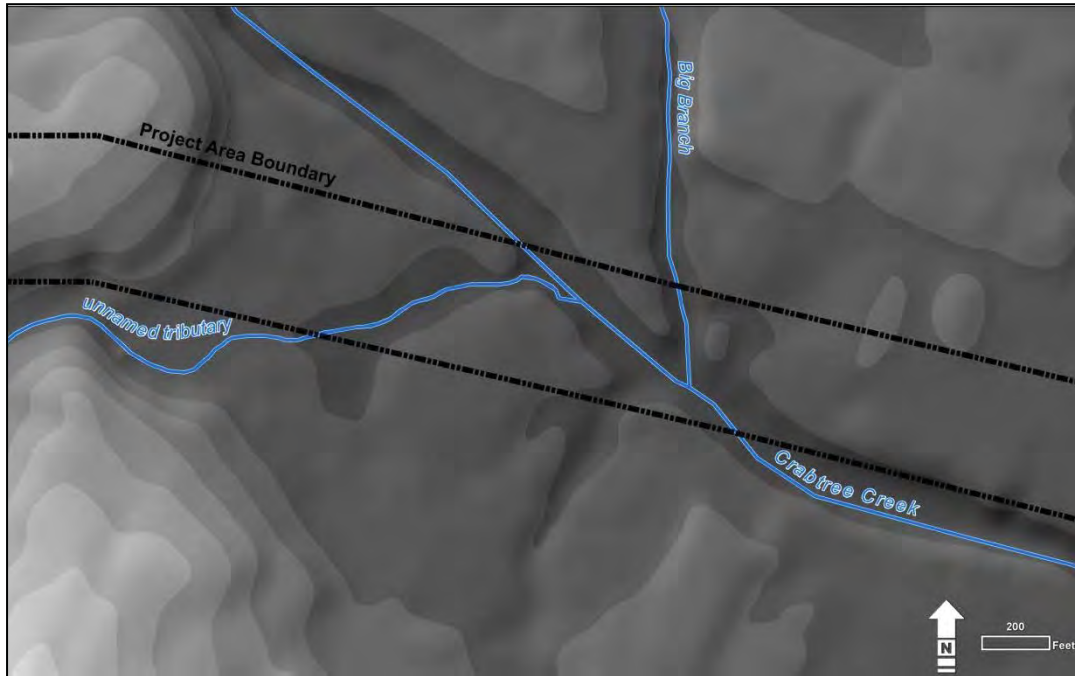
These figures are associated with evaluation area determination Example 3. Figure 8A depicts a portion of a project that encompasses a road crossing of Crabtree Creek and two unnamed tributaries. Figure 8B depicts the watershed of each reach that occurs within the project area.

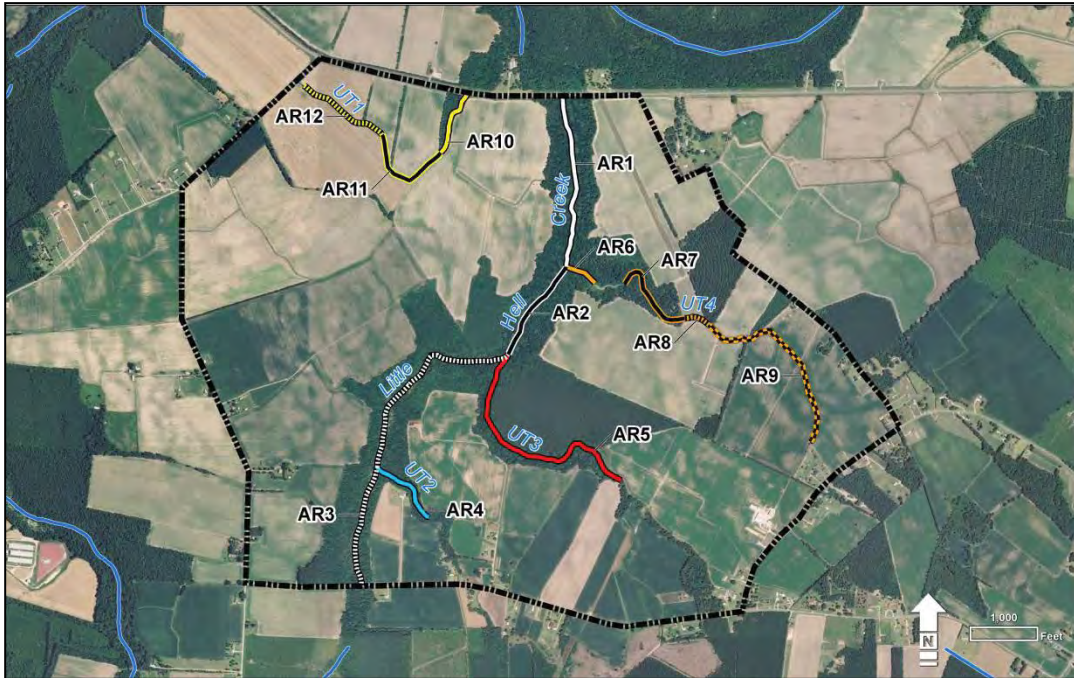
These figures represent evaluation area determination Example 4. Figure 9C depicts project assessment reaches (AR1 through AR12) on an aerial photograph map, and Figure 9D depicts project assessment reaches (AR1 through AR12) on a topographic map.

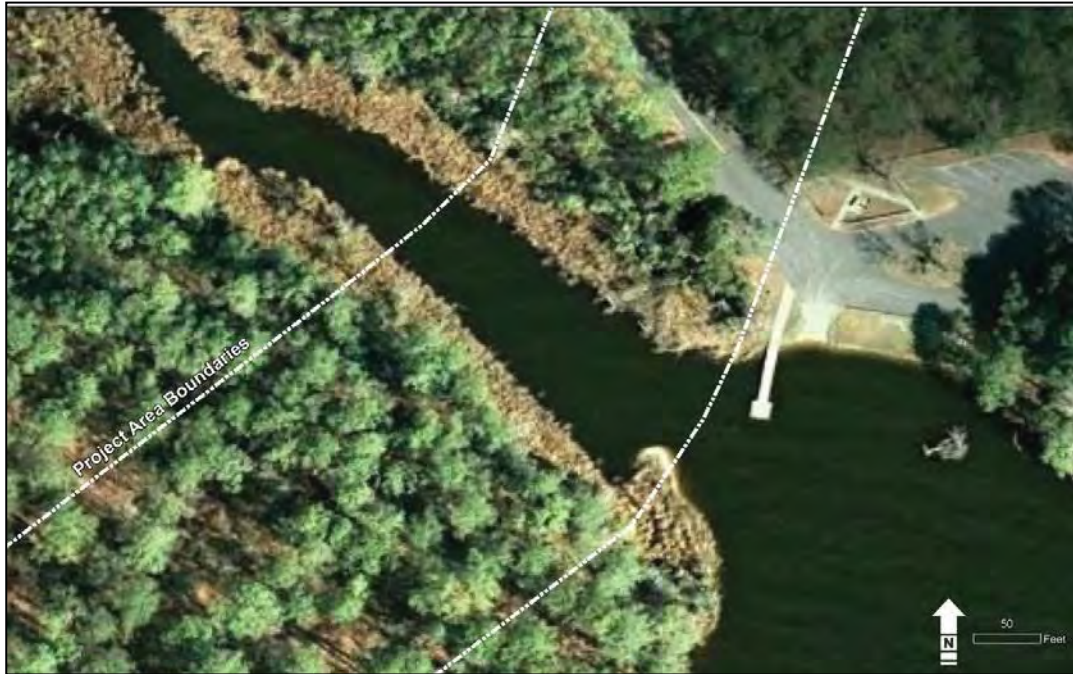
These figures are associated with evaluation area determination Example 5. Figure 10A depicts a portion of a project that encompasses a road crossing of an unnamed tributary to Goose Creek in Beaufort County. Figure 10B depicts the extent of intertidal zone marsh on each side of the assessment reach, which together form the assessment area.

Figures 10A and 10B focus on a project that crosses an unnamed tributary to Goose Creek in Beaufort County. Figure 10A depicts the project area tributary on an aerial photograph base map.

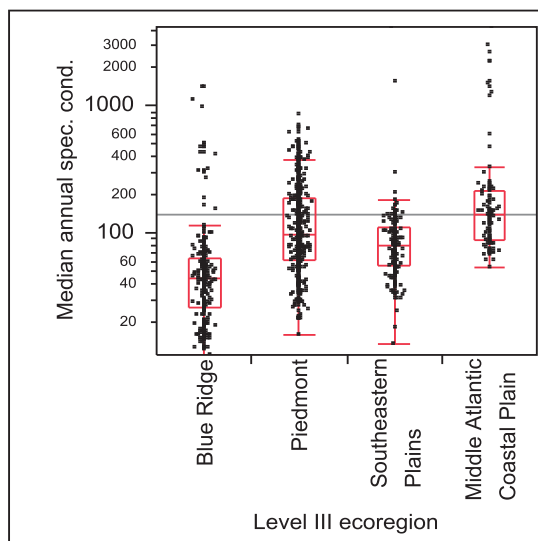
Figure 3 Distributions of annual median specific conductance ($\mu\text{S}/\text{cm}$ at 25°C) by ecoregion. The gray line indicates the grand mean.

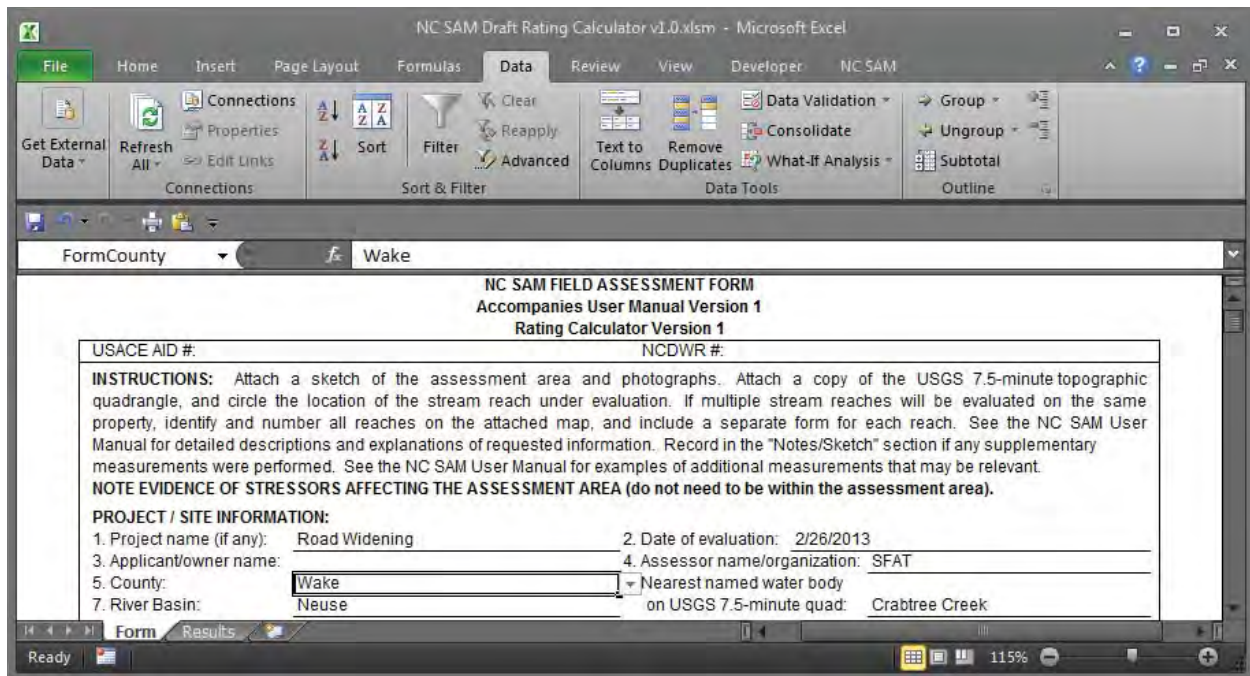
Figure K-5. Text field and combo box items on the Form worksheet.
